### 2.1.5 Accessibility

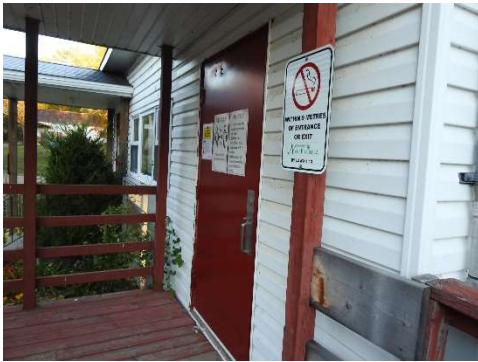
The building is not compliant to Section 3.8 of the Ontario Building Code. The main entry door has a 33" clear width while 33.5" is required. The door is also not equipped with an automatic opener.

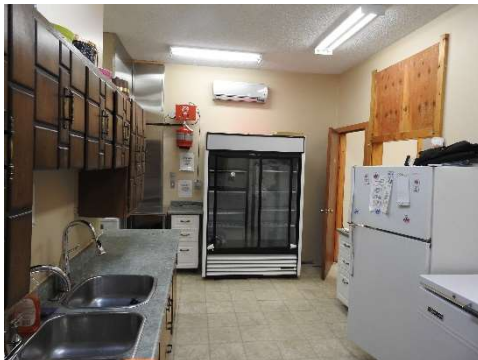
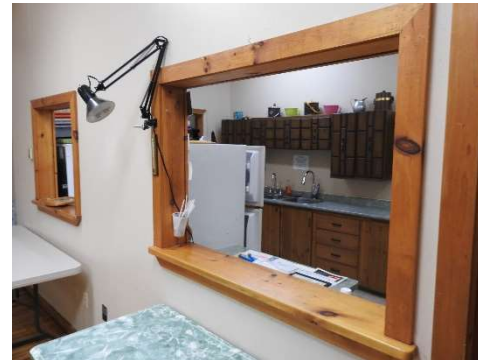
Interior paths are at or are slightly above the minimum width of 43.3". Doorways generally have a clear width greater than the minimum of 33.5" (34.5" and 37" widths). Auto door openers are not installed at the washrooms.

The kitchen counters, island and pass-through counter are not designed for barrier-free use.

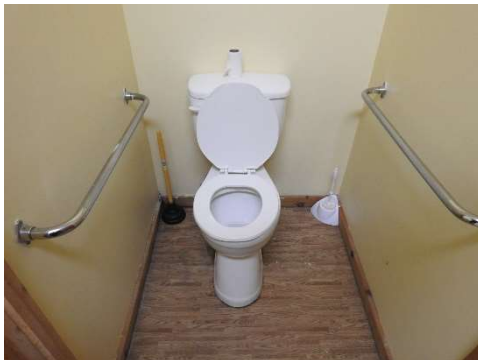
The two washrooms are not designed for barrier-free use despite the installation of grab bars. We noted the following issues: Use of steel sinks, inadequate knee space at vanities, uninsulated drain piping, wrong type of faucets, entry doors are not automated, toilet stall doors are narrow at 32" width, stall size is less than 60"x60", light switches are greater than 48" AFF, toilet paper dispensers are at 40" AFF and 12" out from rim.

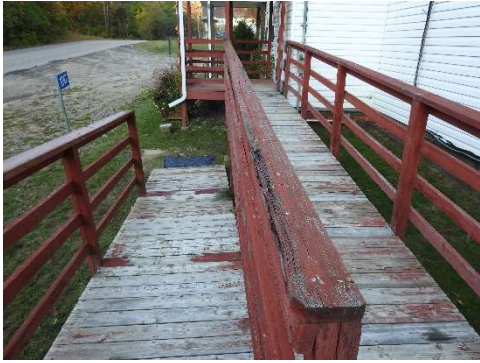
The exterior ramp is older but is generally designed with compliancy. We noted that the handrails are non-graspable, handrails are installed above the 34" to 38" AFF requirement, the slope of 7% is less than the maximum of 8.3%, the width of 45" is greater than the minimum of 36", and there is no curb feature along the ramp perimeter. The ramp should be replaced.

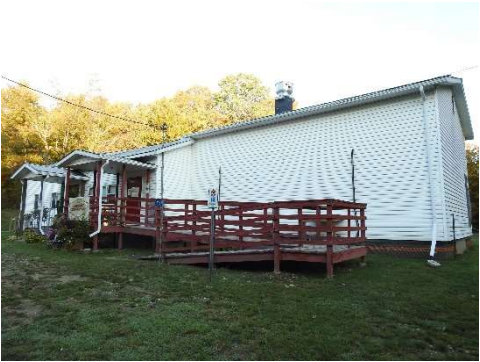
The site has a single barrier-free parking stall. Improvement to surfacing, transition to ramp landing, and improved demarcation is required. Consider additional designated stalls.
