Committee of the Whole – Regular Meeting
March 5, 2014 – 9:00 a.m.
The Frontenac Room, 2069 Battersea Road, Glenburnie, ON

Report 2014-029

**Re: Corporate Services – Performance Concepts Consulting Inc. –
County of Frontenac Strategic Plan Draft Report**

Joint Project for Frontenac Townships

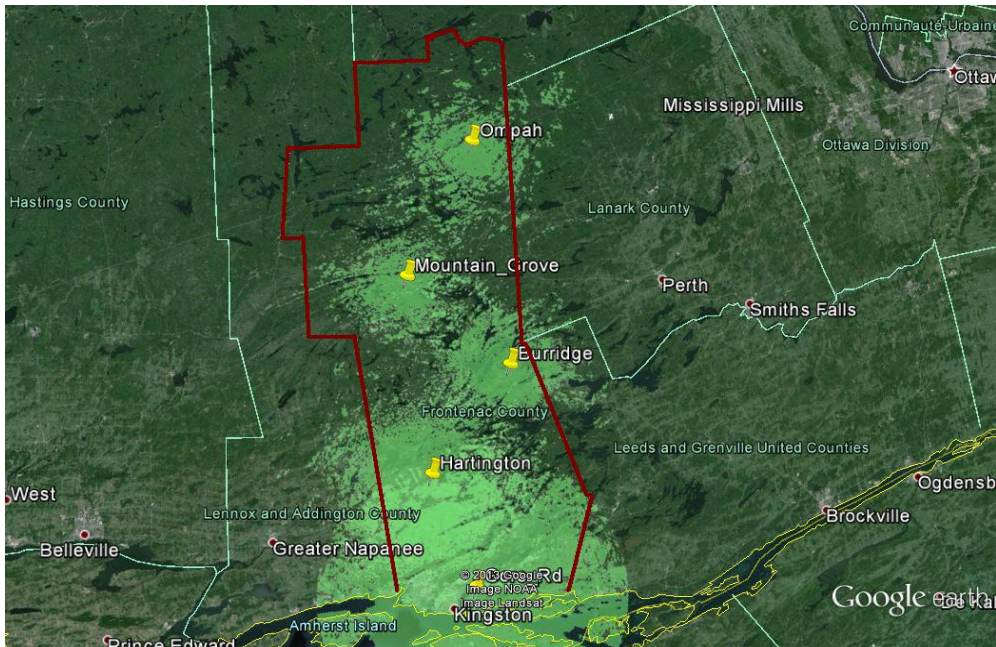
As shown below, dead spots are apparent in large sections of Central and North Frontenac and some sections in South Frontenac. The conclusion from this analysis indicates that the current RF Coverage is not adequate to provide reliable Radio Communications across the entire Frontenac region.

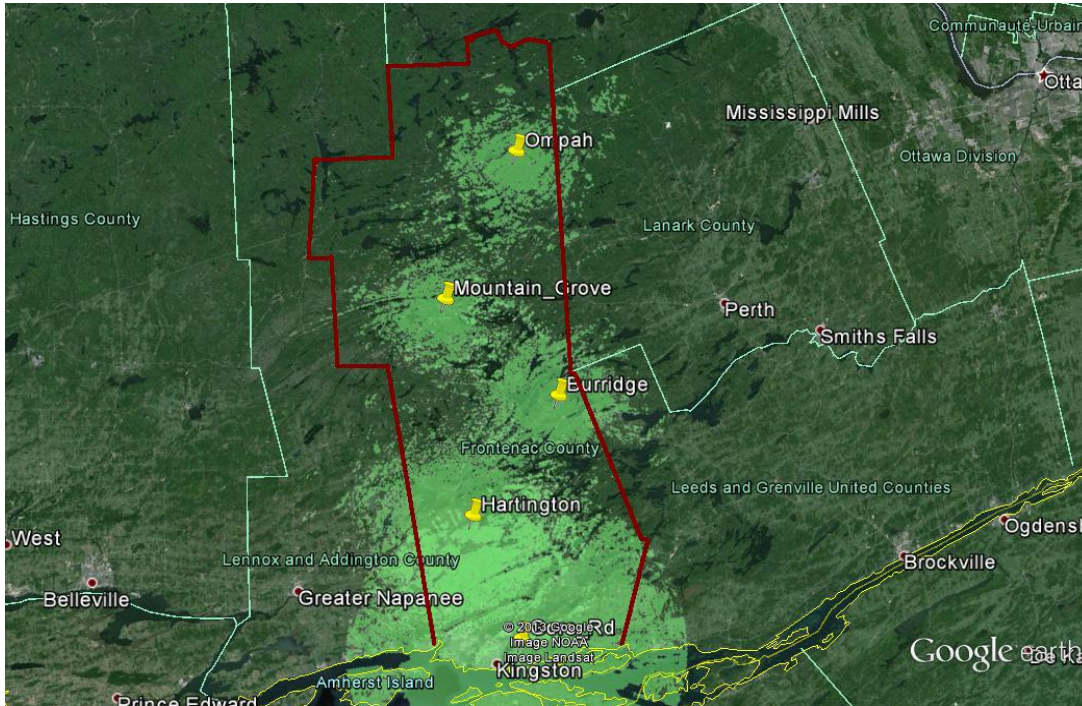
Combined Sites 95/95 Serviceability Area

This combined plot shows the estimated 95/95 serviceability for the Frontenac region when combining all of the results from the 5 sites. Dead spots are apparent in large sections of Central and North Frontenac and some sections in South Frontenac. The conclusion from this analysis would indicate that current RF Coverage is not adequate to provide reliable Radio Communications across the entire Frontenac region.

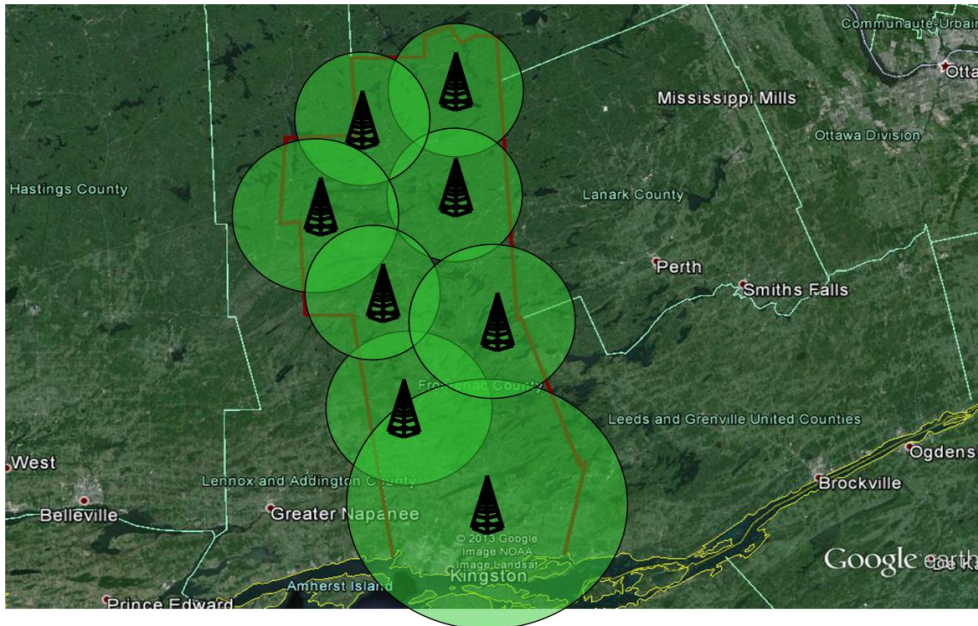
As shown below, additional Repeater sites will need to be constructed in order to fill in the dead zones and ensure complete communications coverage across the Region.

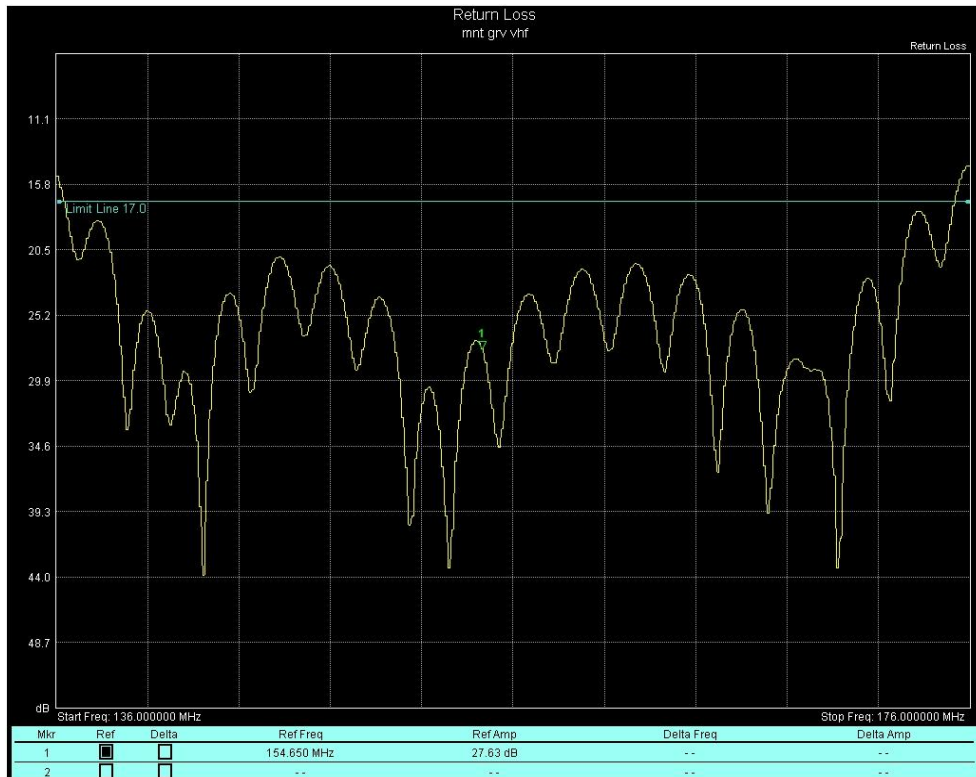
Figure 1: Mountain Grove VHF antenna and feed line Return loss

A good result would have most of the plot underneath the 17 dB limit line. This is the case with this antenna and feed line.

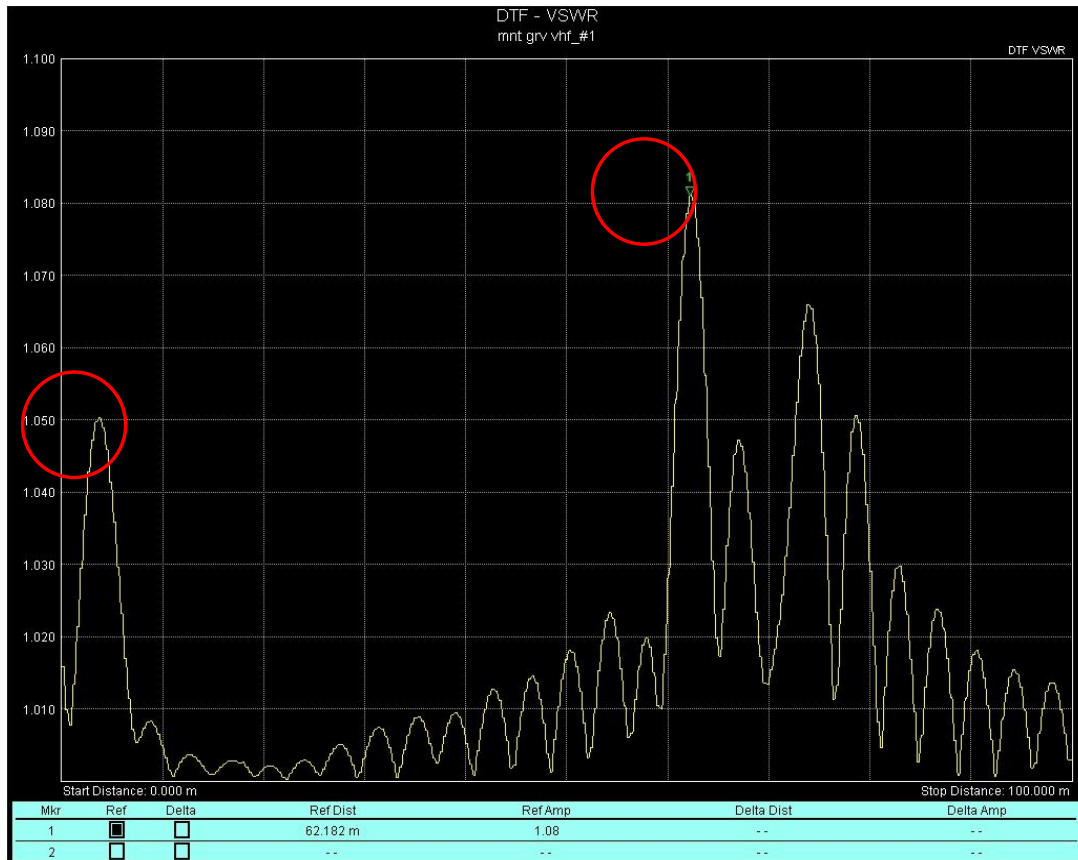
Figure 2: Mountain Grove VHF antenna and feed line Distance To Fault.

The distance to fault plot shows a normal return along the length of the cable.

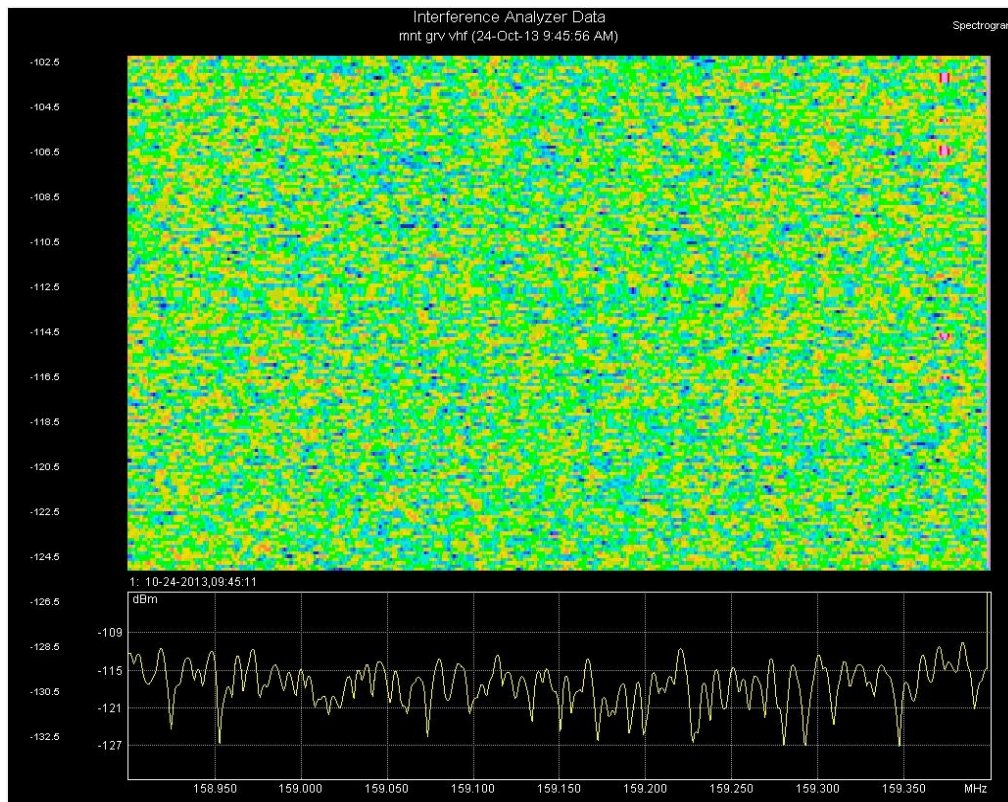
Figure 3: Mountain Grove Fire service receiver IA.

The Spectrogram captured no interferers and established the noise floor at this frequency to be nominally -115 dBm which is acceptable for a rural location such as this.

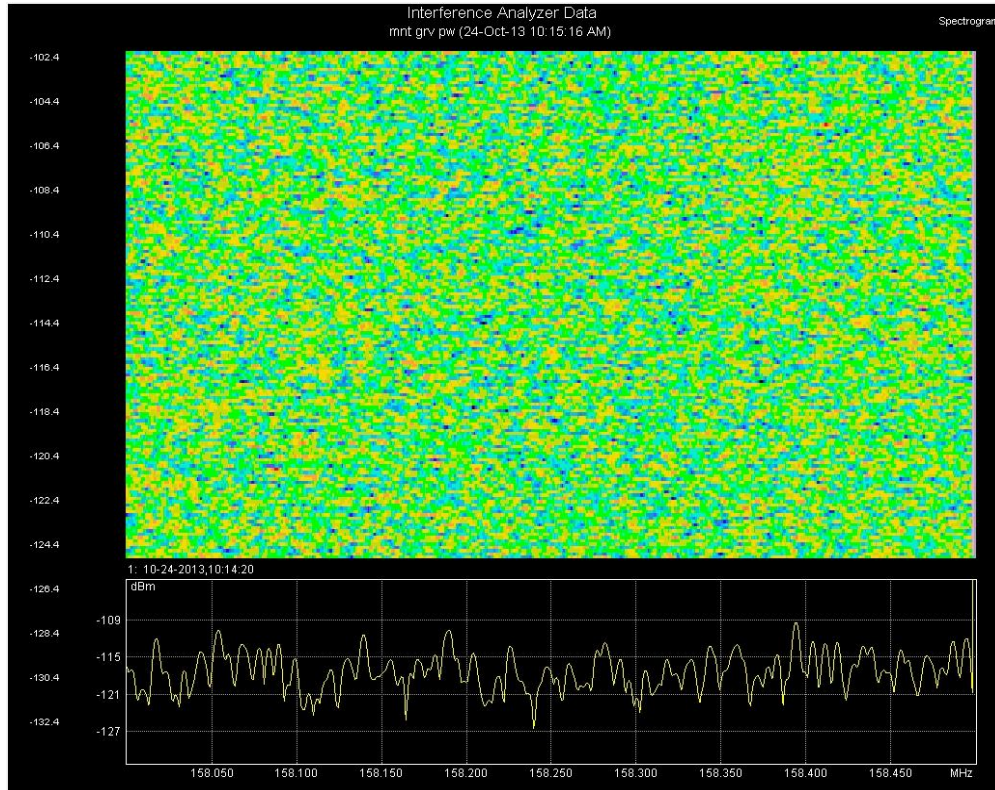
Figure 4: Mountain Grove Public works receiver IA

The Spectrogram captured no interferers and established the noise floor at this frequency to be nominally -115 dBm which is acceptable for a rural location such as this.

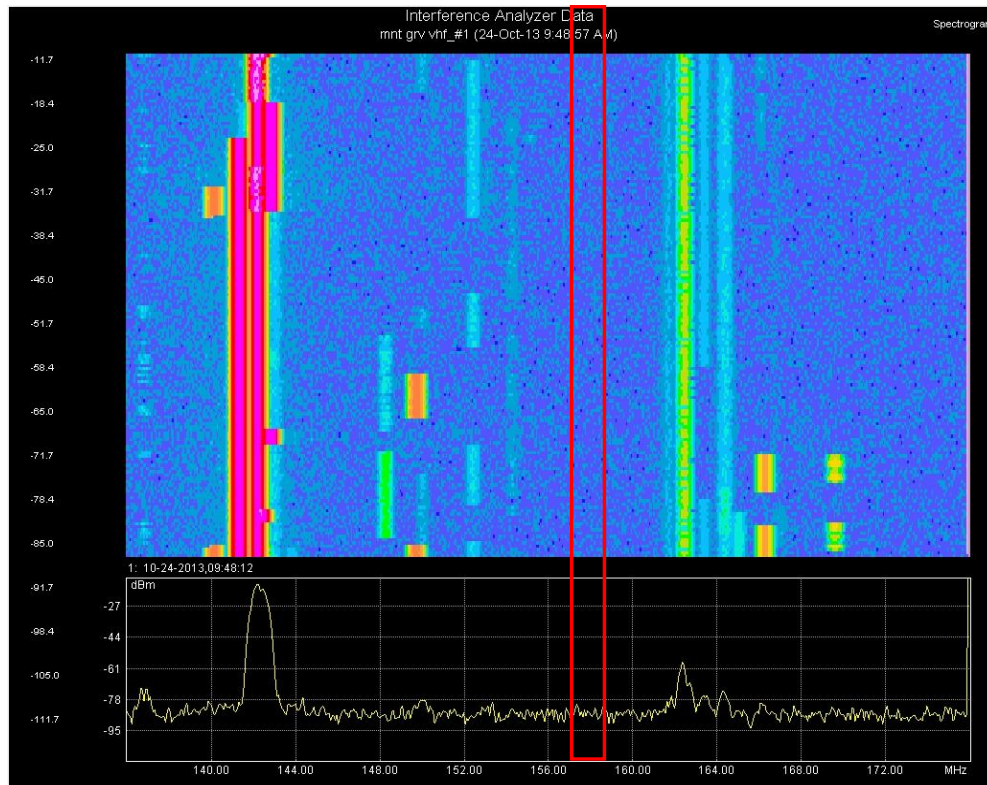
Figure 5: Mountain Grove VHF spectrum IA.

While there are some powerful carriers in the area, the spectrum is clear in the portions used by both Fire and Public works systems.

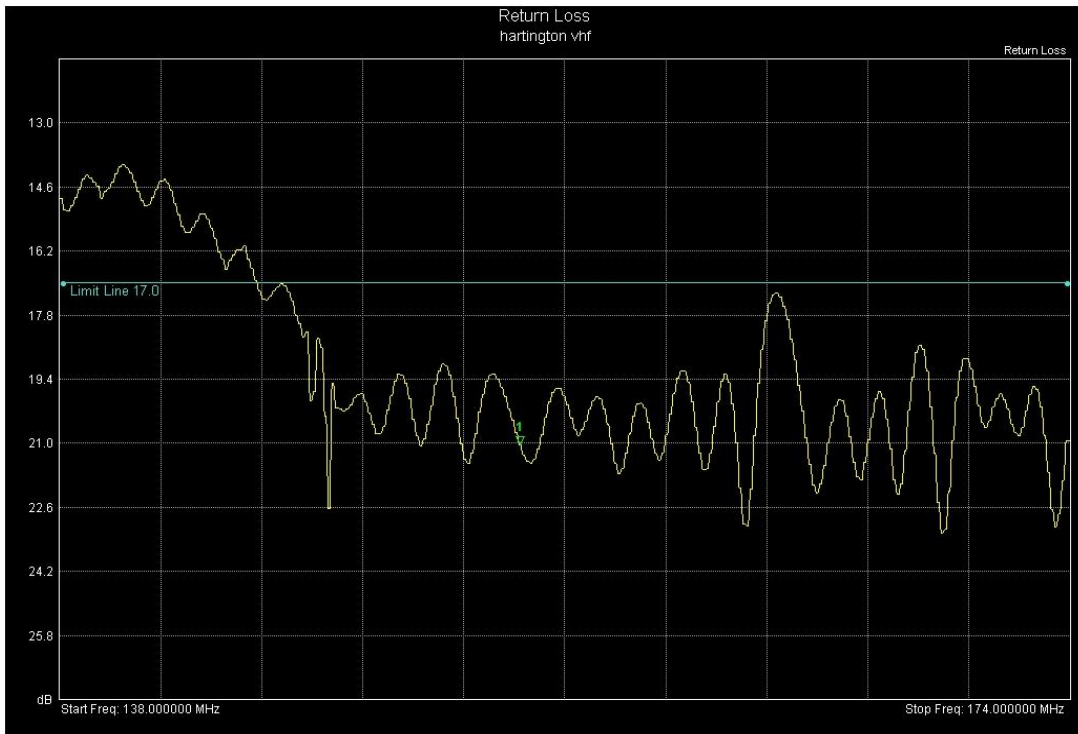
Figure 6: Hartington VHF antenna and feed line Return loss

This antenna and feed line plot shows a good result. There is an elevated return on the left hand side of the plot but this is below the 145 MHz mark and therefore does not affect the Fire and Public works stations as they transmit and receive above that portion.

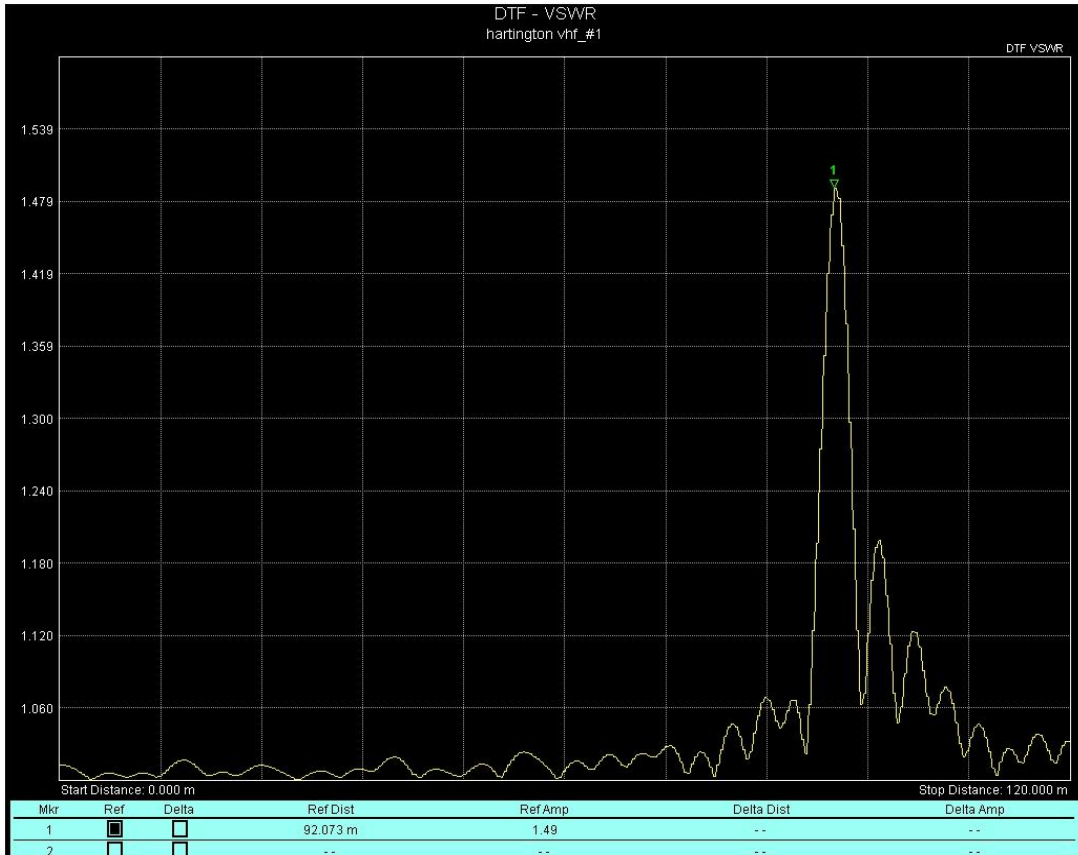
Figure 7: Hartington VHF antenna and feed line Distance To Fault.

The distance to fault plot shows a normal return along the length of the cable.

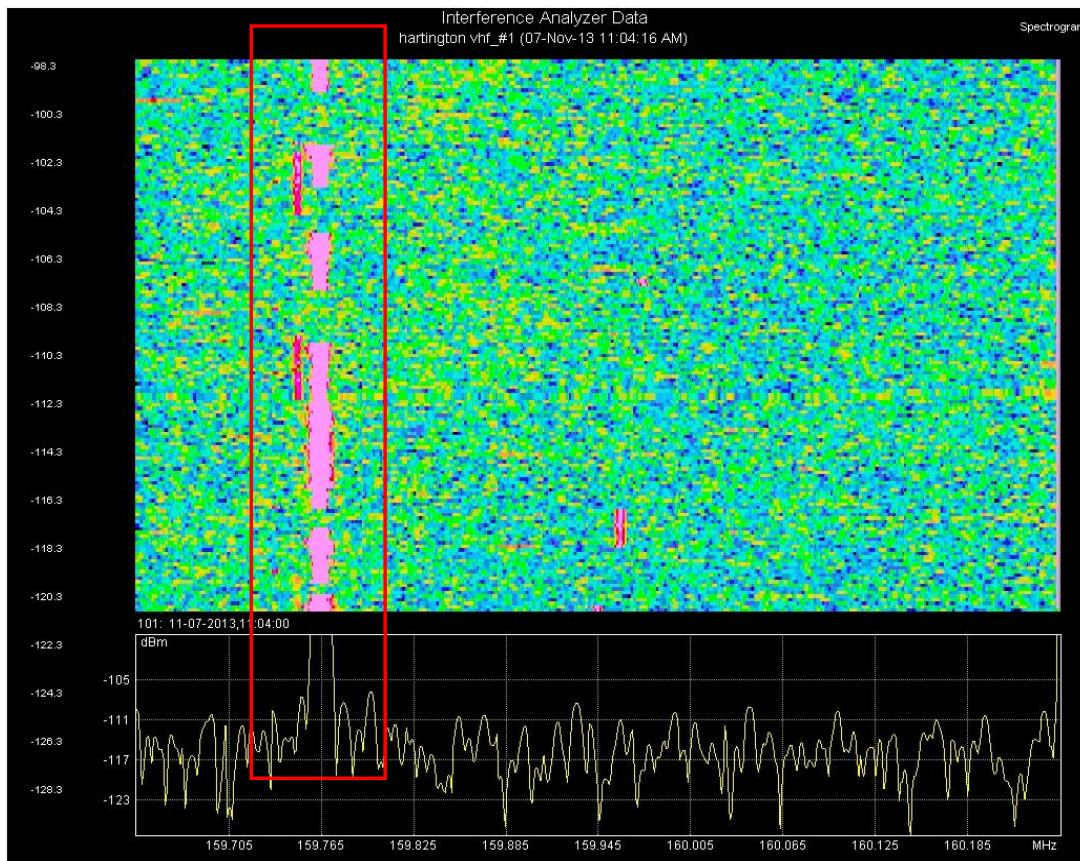
Figure 8: Hartington Fire service receiver IA.

The Spectrogram captured no interferers at the receiver’s center frequency but there is an adjacent carrier that falls within the pass band of the filters and therefore will present itself to the receiver’s front end.

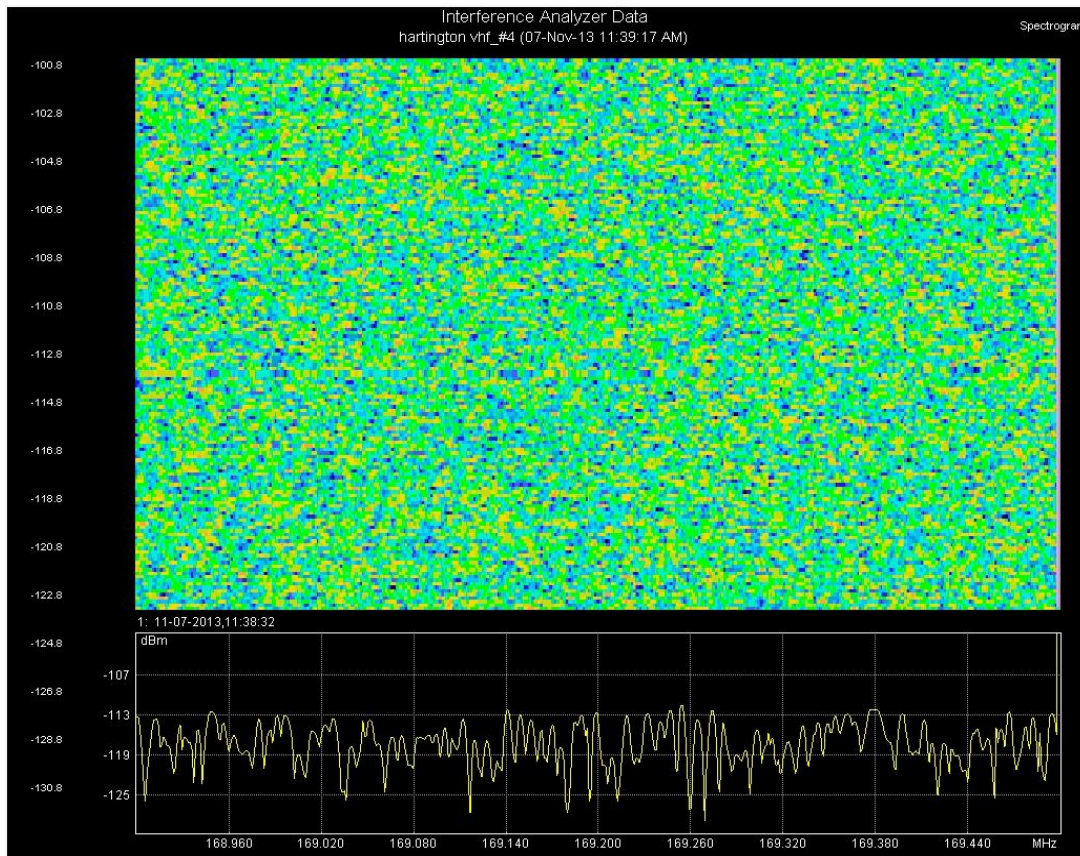
Figure 9: Hartington Public works receiver IA

The Spectrogram captured no interferers and established the noise floor at this frequency to be nominally -113 dBm which is acceptable for a busy rural location such as this.

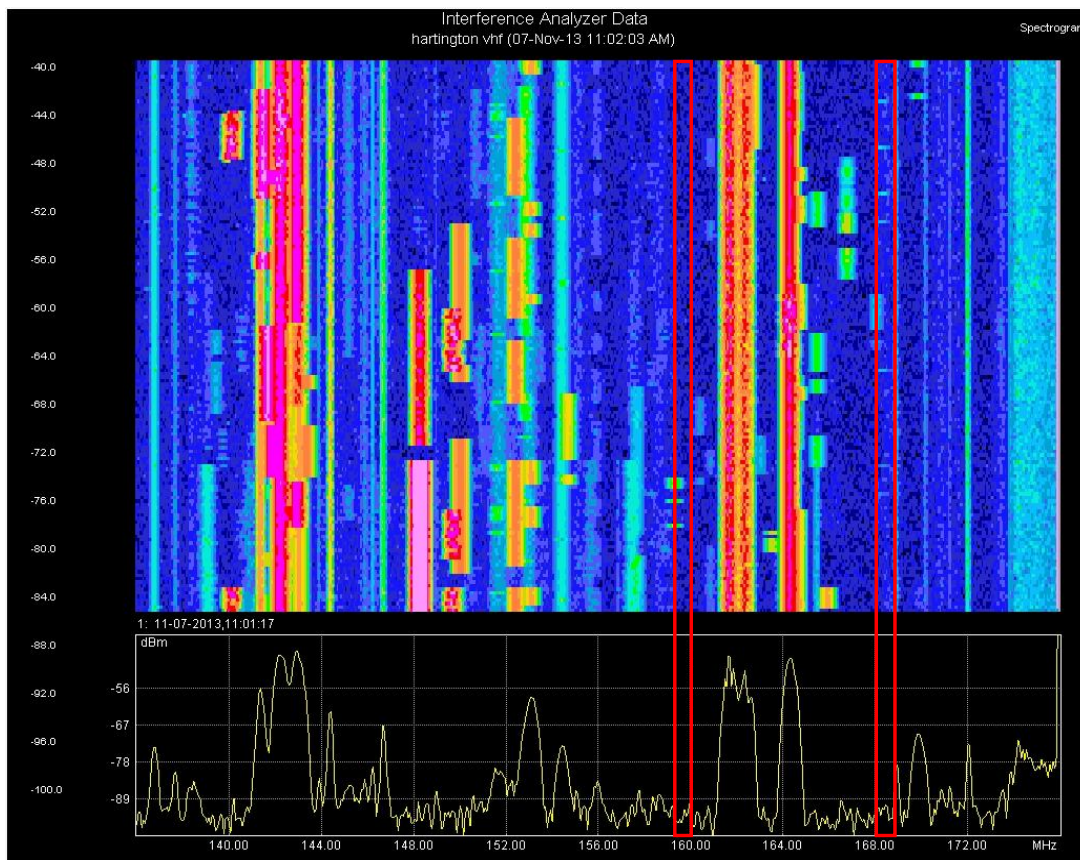
Figure 10: Hartington VHF spectrum IA.

This is a busy site and the VHF spectrogram shows this clearly.

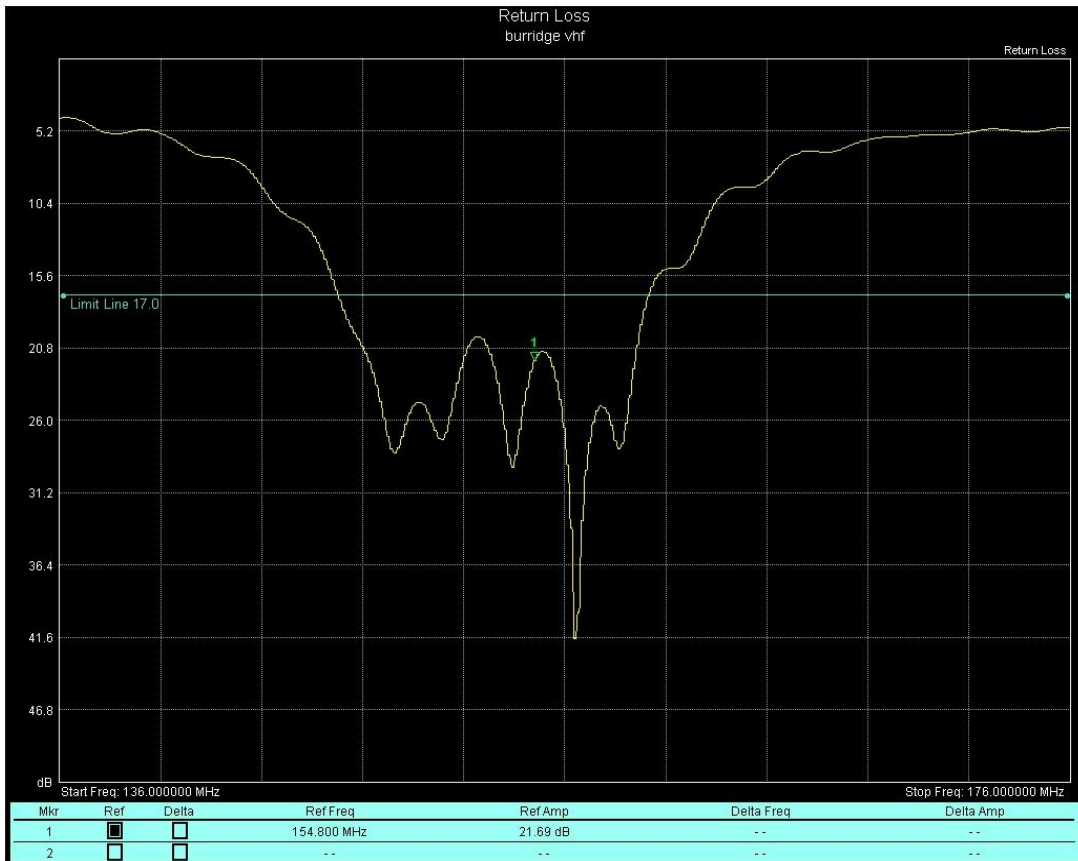
Figure 11: Burrige VHF antenna and feed line Return loss

A good result would have most of the plot underneath the 17 dB limit line. In this instance the antenna is not a wide band device and is therefore only properly resonant at and around the center frequency of the transmitter.

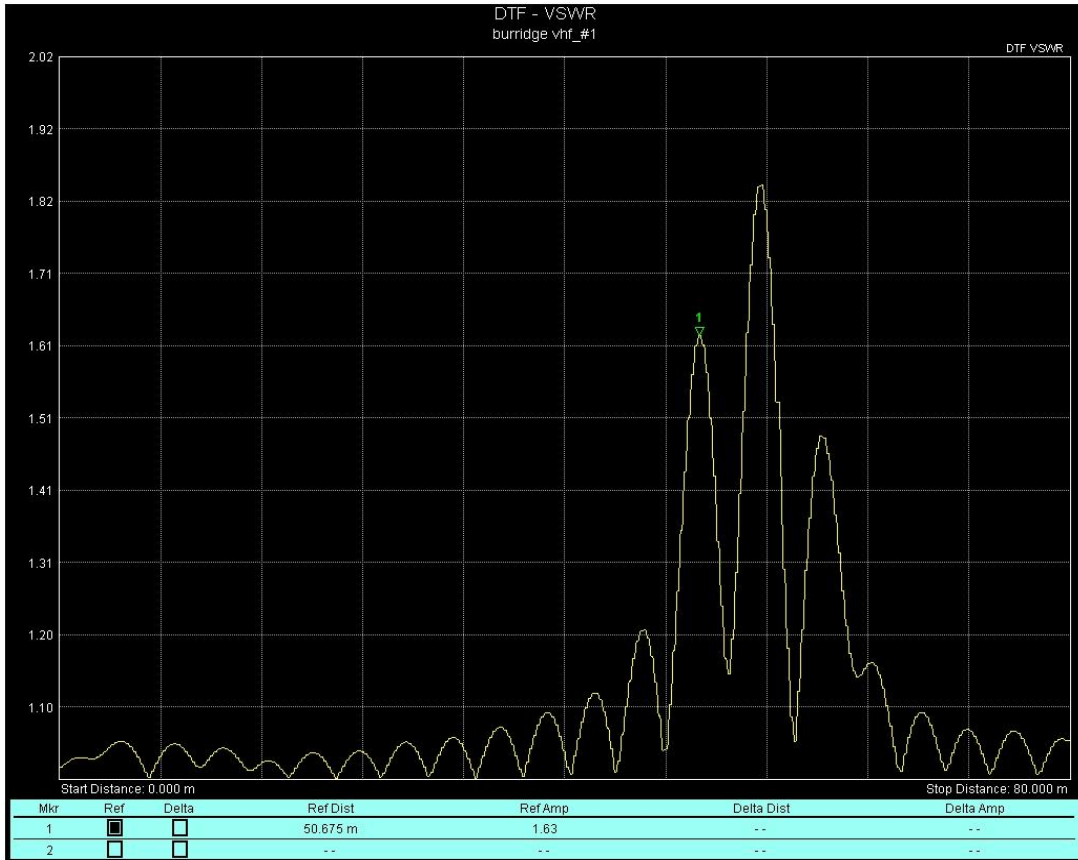
Figure 12: Burrige VHF Distance to Fault

The distance to fault plot shows a normal return along the length of the cable.

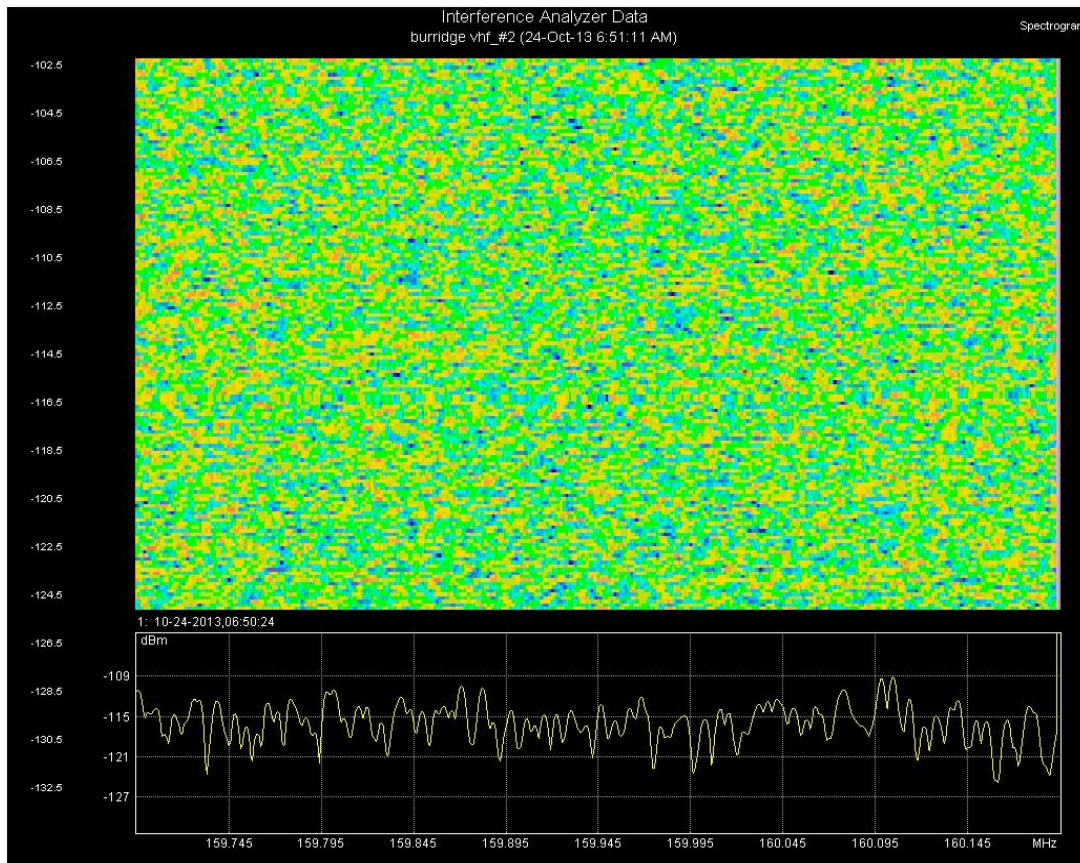
Figure 13: Burr ridge Fire service receiver IA.

The Spectrogram captured no interferers and established the noise floor at this frequency to be nominally -111 dBm which is acceptable for a rural location such as this.

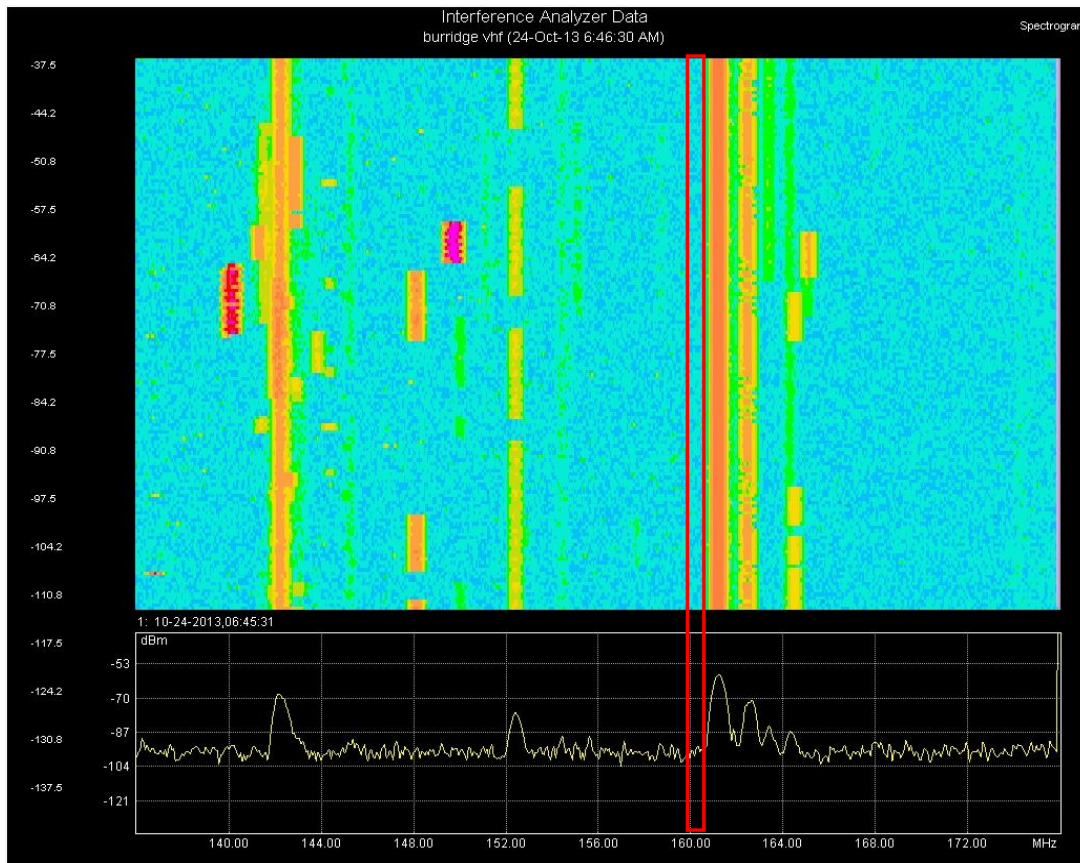
Figure 14: Burrige VHF spectrum IA.

There is more activity along the spectrum at this location than was expected but the receiver portion is quiet.

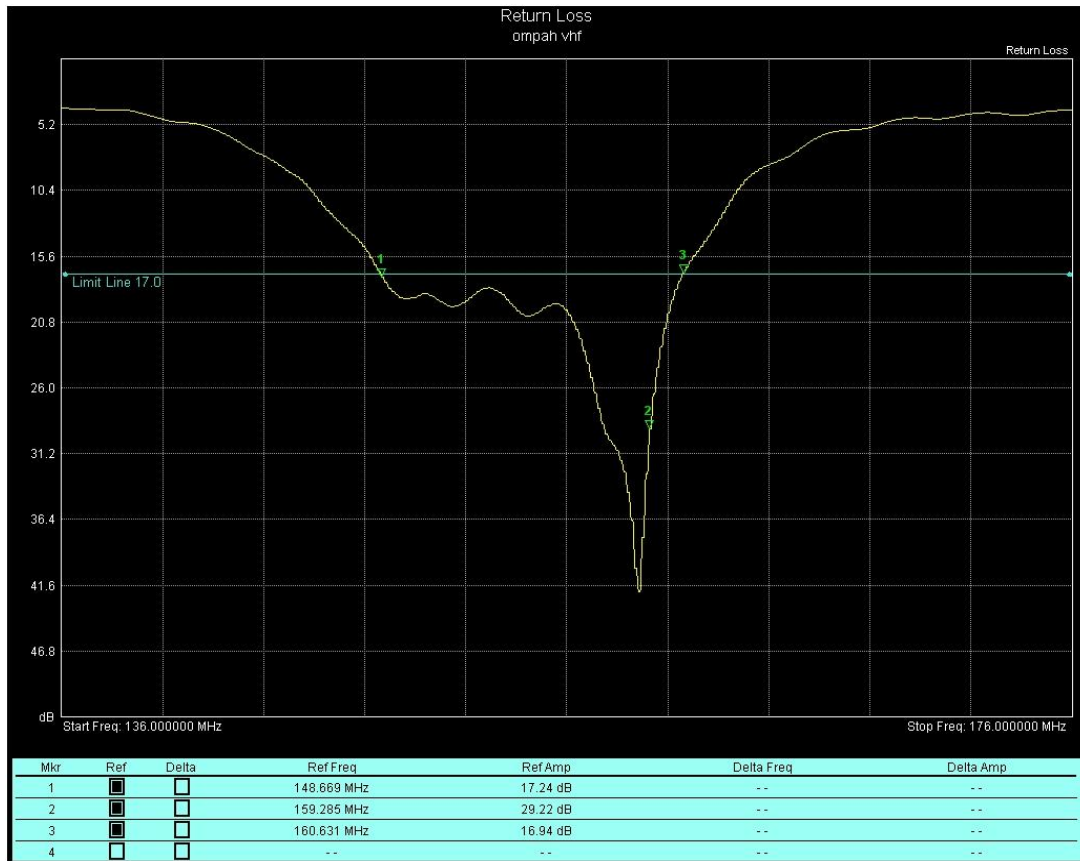
Figure 15: Ompah VHF antenna and feed line Return loss

A good result would have most of the plot underneath the 17 dB limit line. In this instance the antenna is not a wide band device and is therefore only properly resonant at near the center frequency of the transmitter. Since this base station is the sole user of this antenna this is not considered a problem.

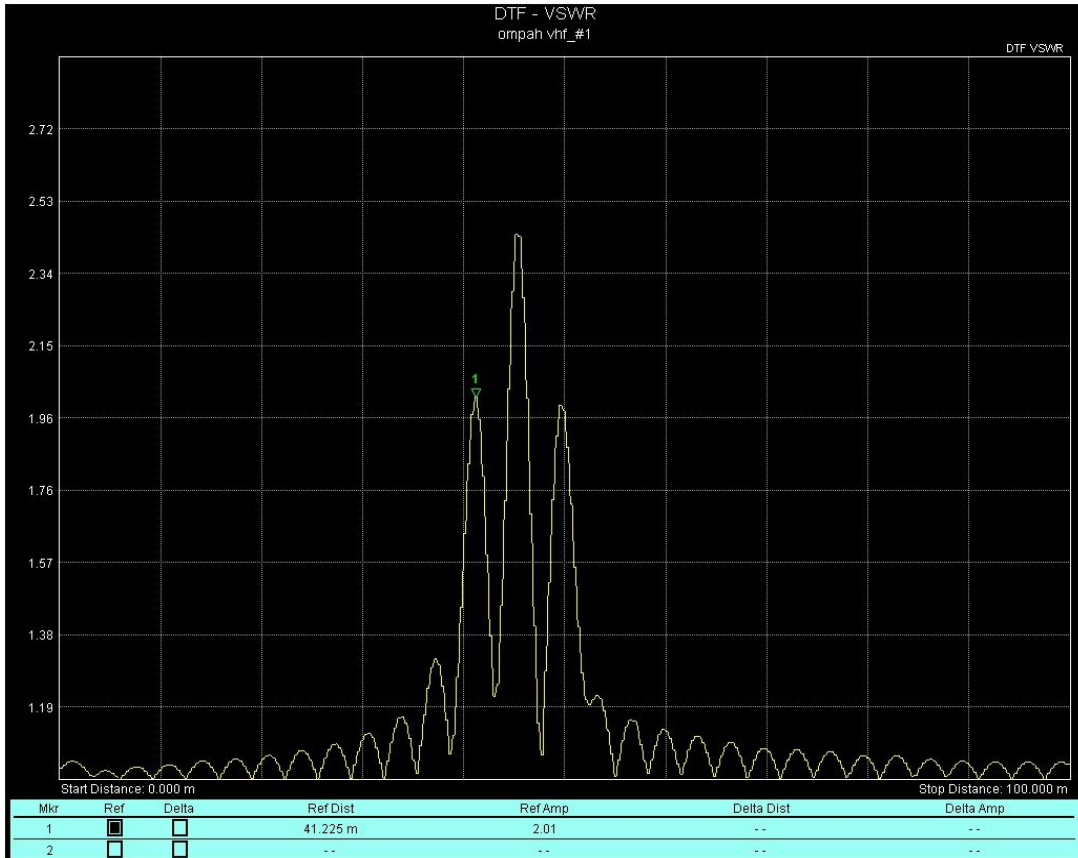
Figure 16: Ompah VHF antenna Distance to fault

The distance to fault plot shows a normal return along the length of the cable.

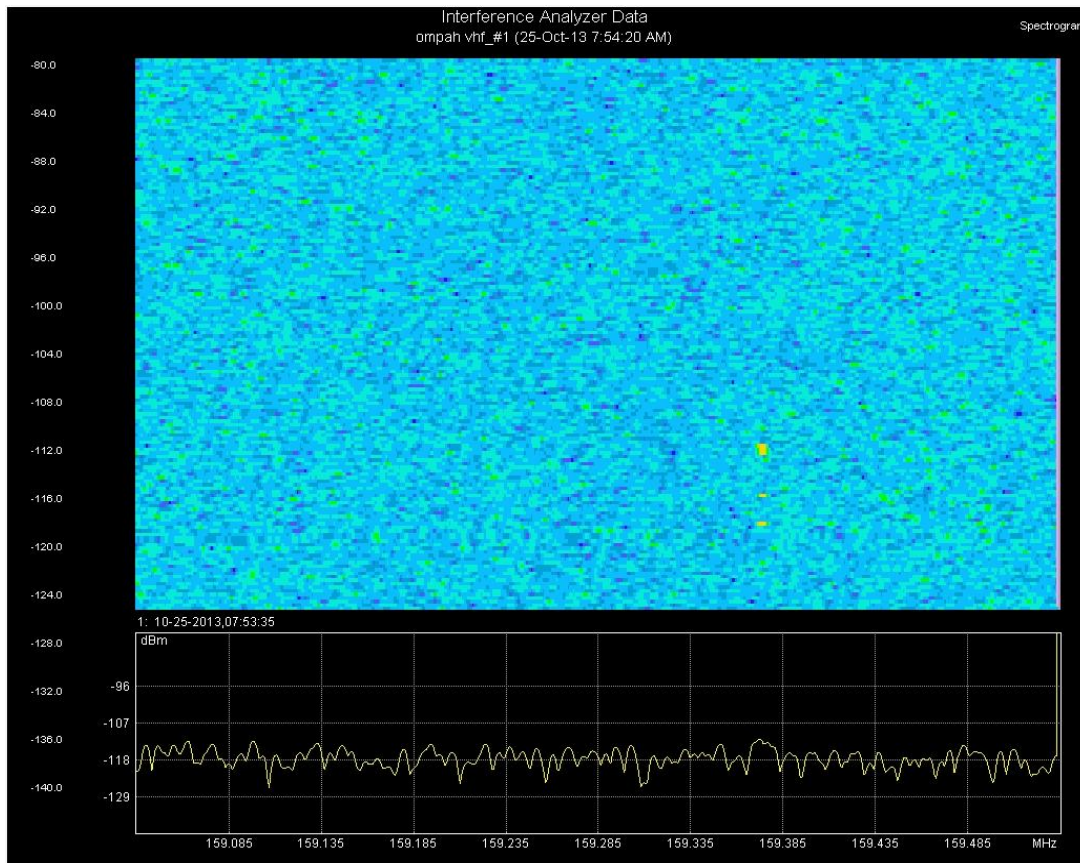
Figure 17: Ompah Fire service IA

The Spectrogram captured no interferers and established the noise floor at this frequency to be nominally -113 dBm which is acceptable for a rural location such as this.

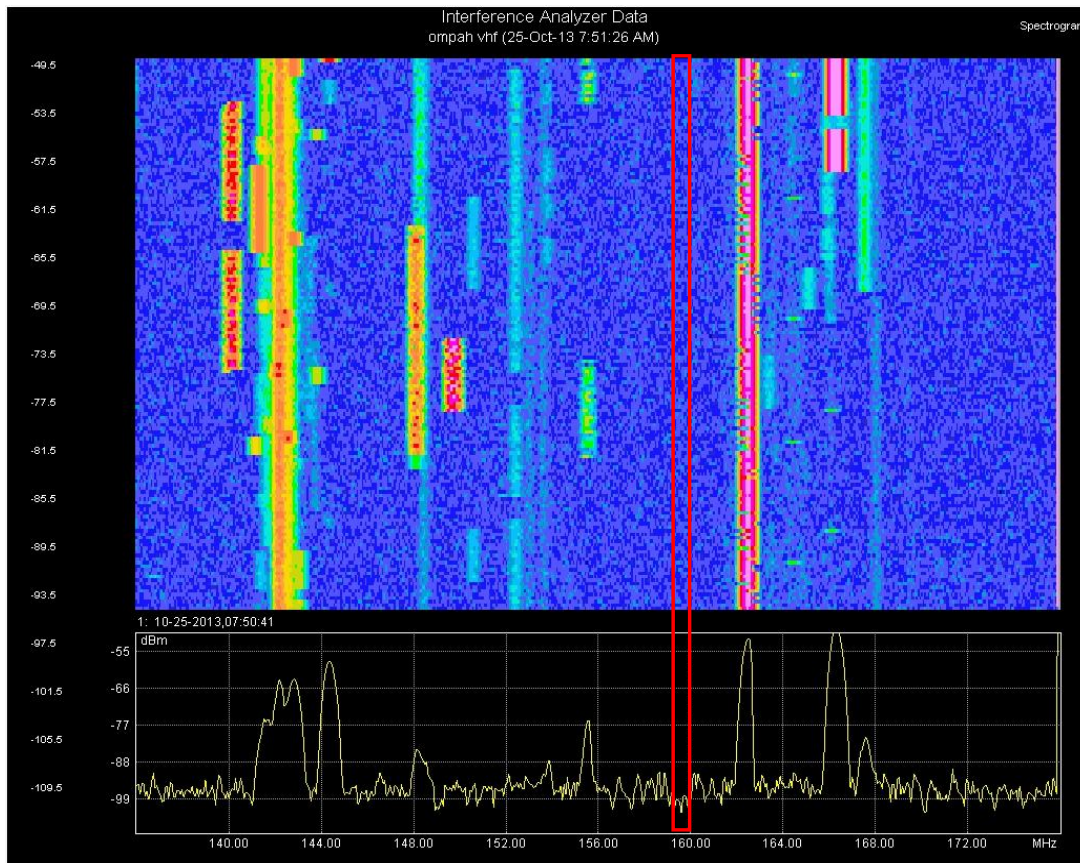
Figure 18: Ompah VHF spectrum IA.

There are numerous carriers in the area but the receiver's portion of the spectrum is clear.

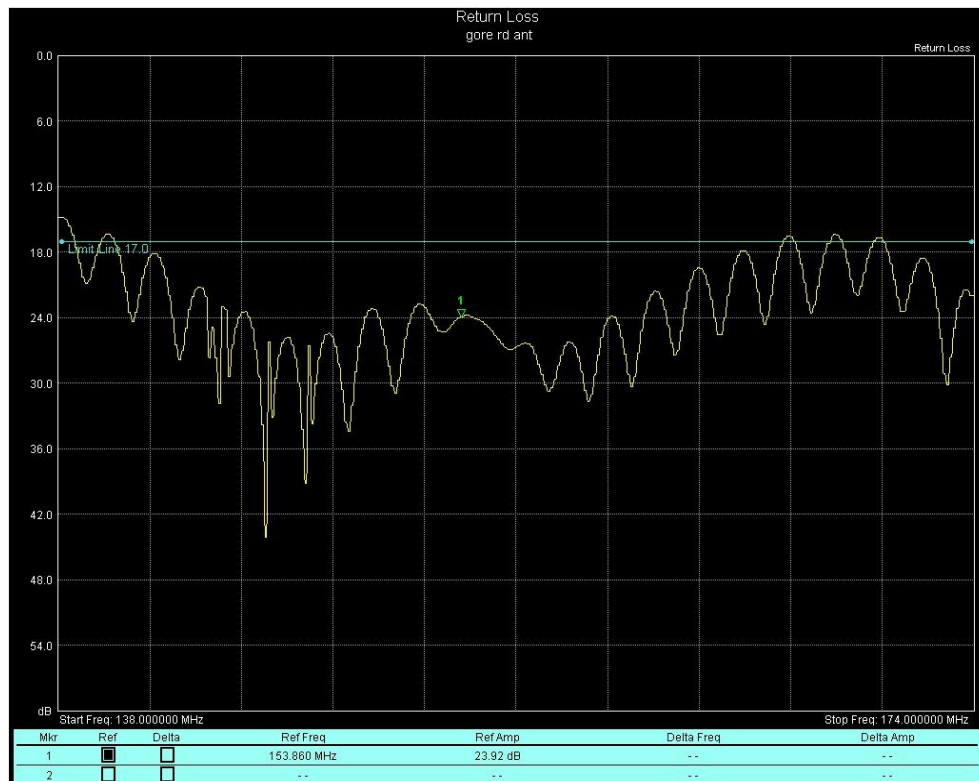
Figure 19: Gore rd. VHF antenna and feed line Return loss

This antenna and feed line plot returned a good result.

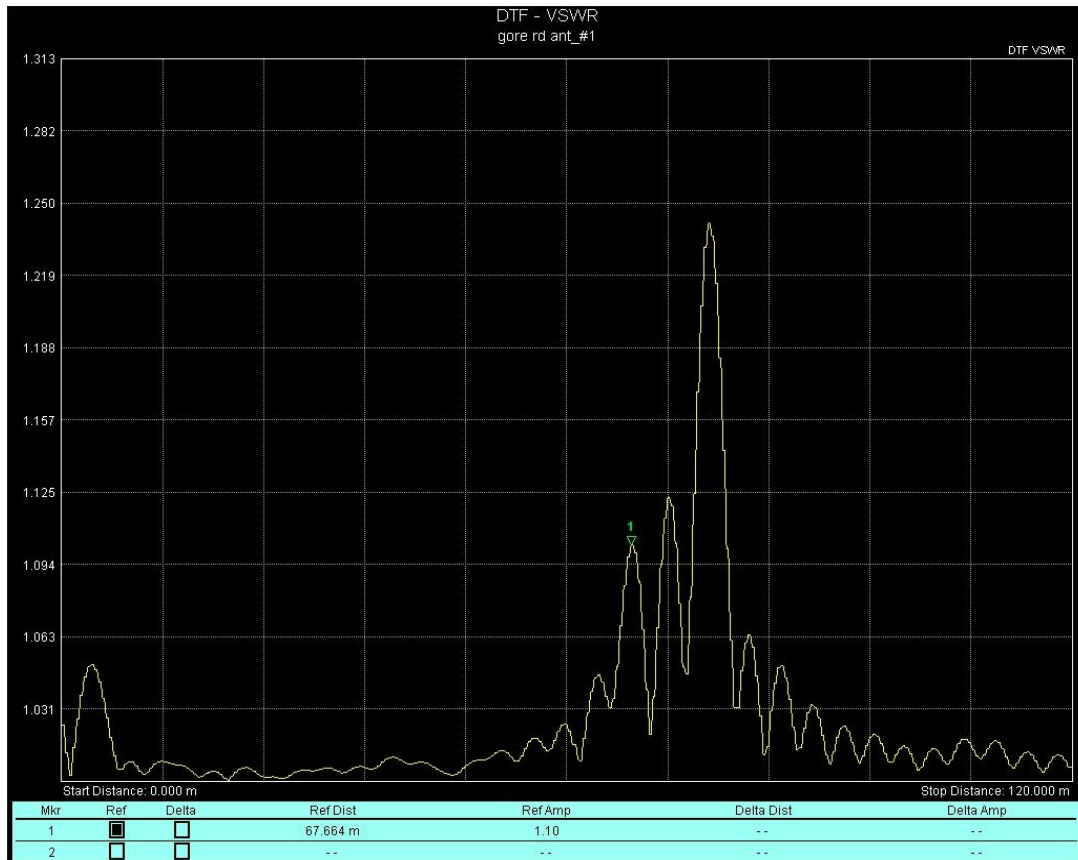
Figure 20: Gore rd. VHF antenna Distance to fault

The distance to fault plot shows a normal return along the length of the cable.

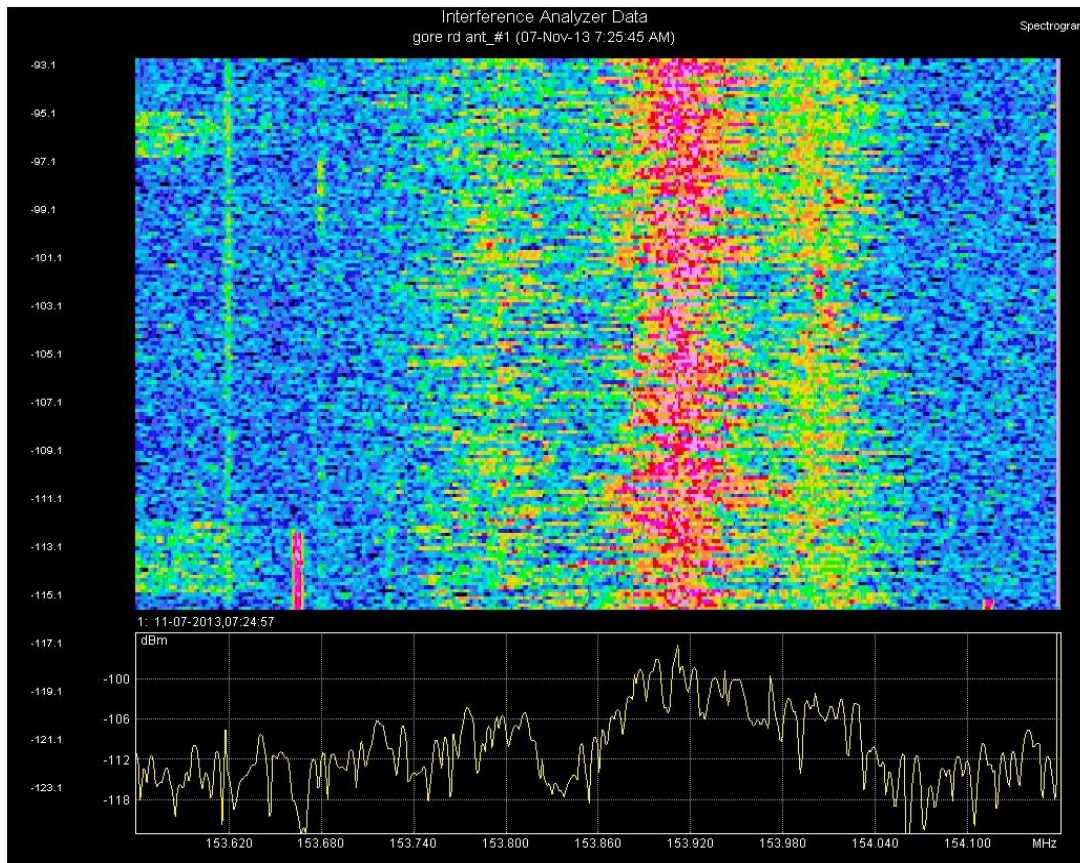
Figure 21: Gore Rd IA

The Spectrogram captured a interferer at 153.920 MHz. It was not possible to estimate the noise floor level at this location due to the presence of the unwanted carrier.

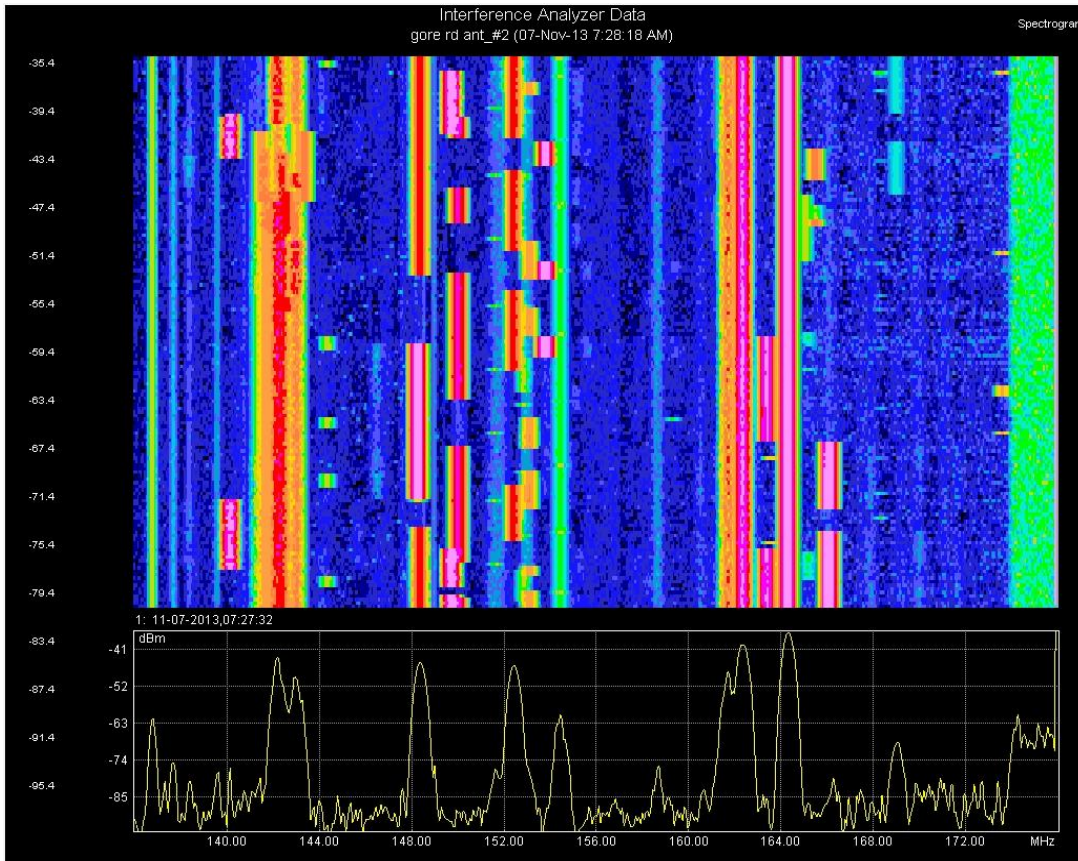
Figure 22: Gore rd. VHF spectrum IA.

As expected from a site in an urban area the spectrum is fairly congested.
