CULVERT ENGINEERING REVIEW

6253 BUCKSHOT LAKE ROAD

REPORT TO COUNCIL MAY 16, 2024

Re: **Township of North Frontenac**
RFQ No. 2023-26
Buckshot Lake Road Culvert Replacement
Our File 230-5280

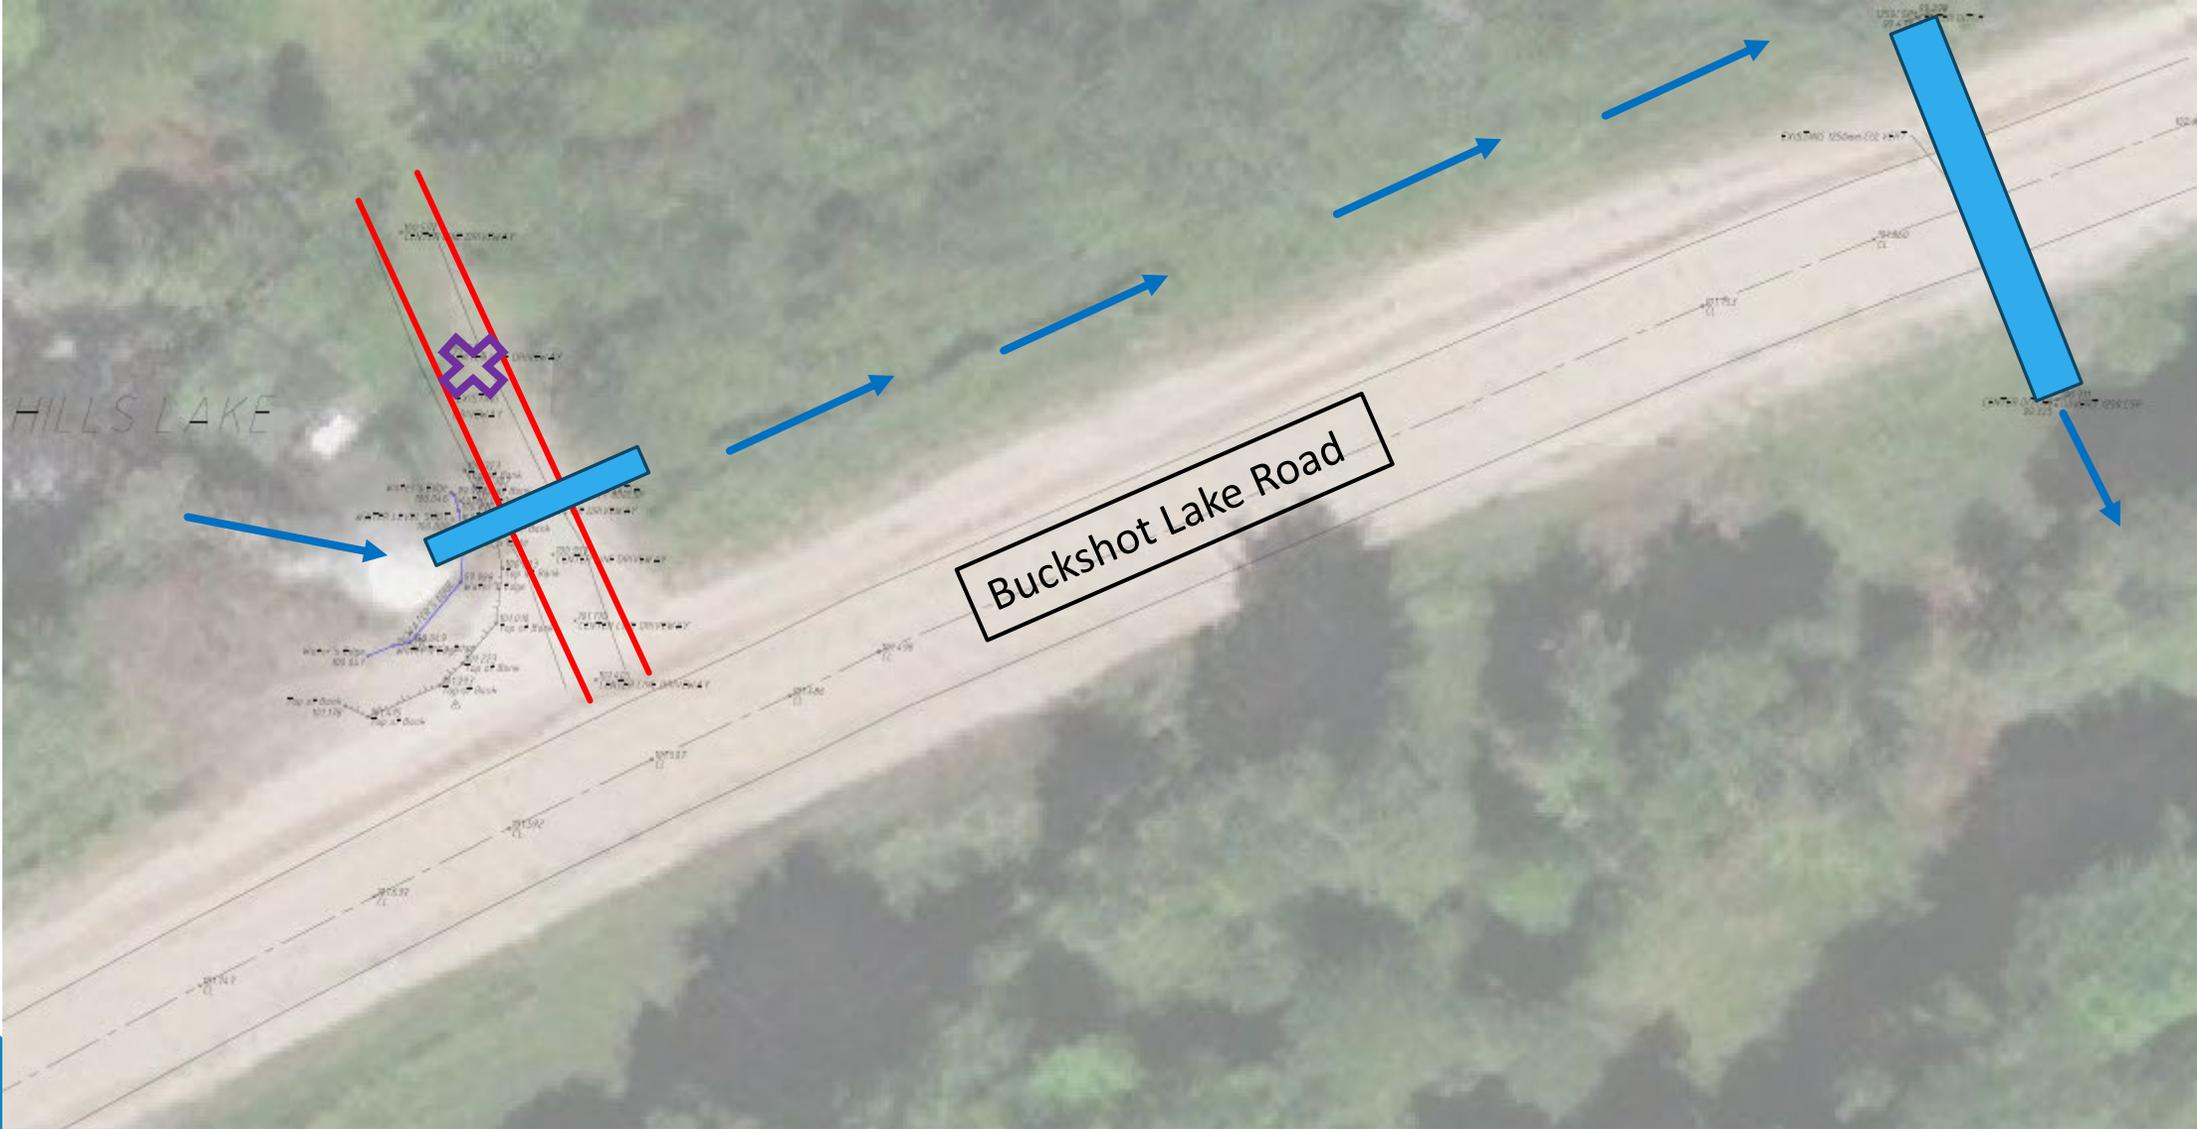
Survey

Topographic survey completed at the culvert and various properties around the lake September 2023.

Lake Level used as baseline

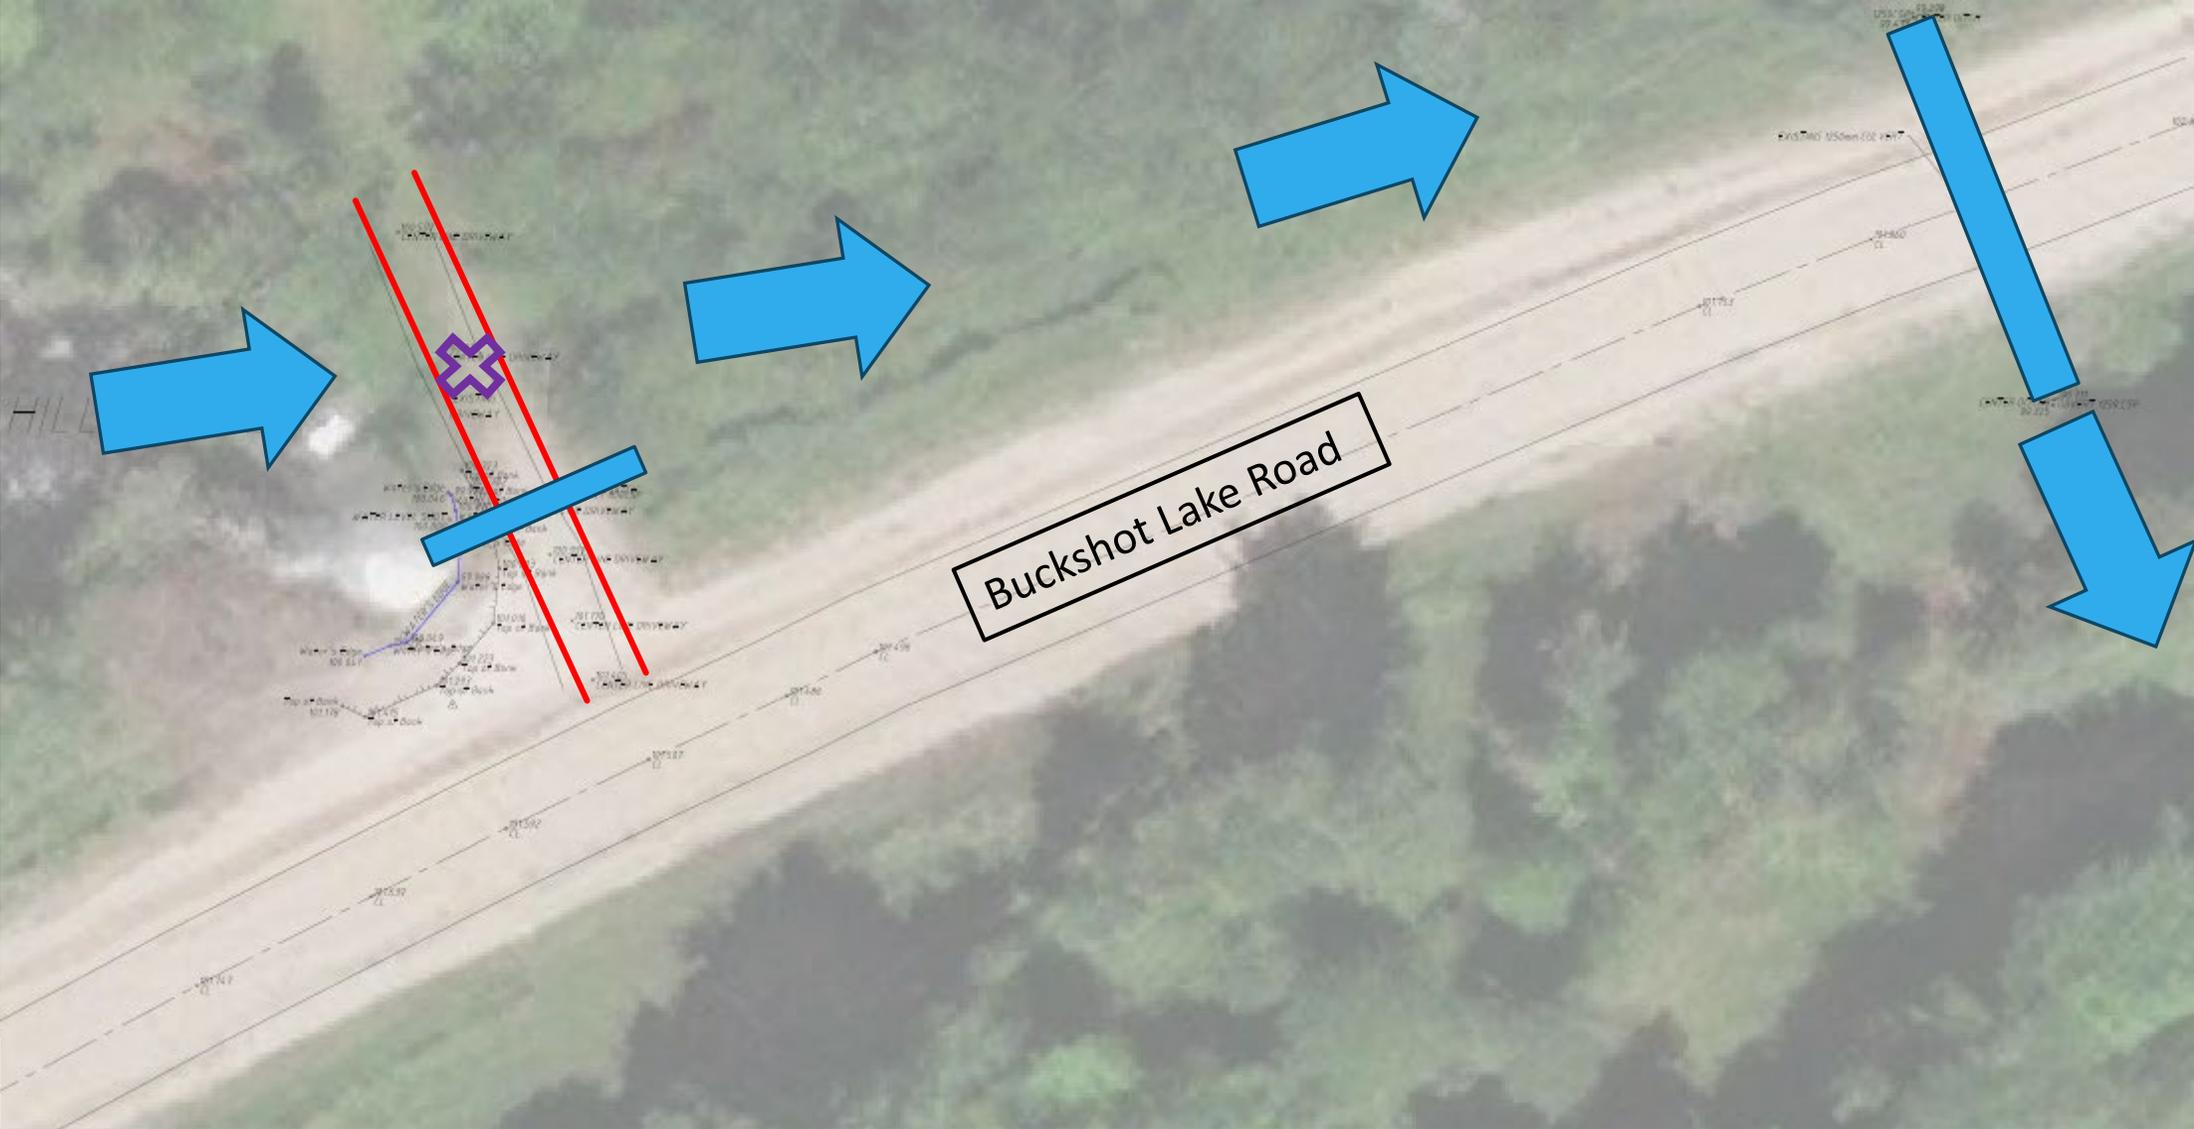
High Flows

During high flow conditions, water would leave the lake through the culvert until the culvert capacity was exceeded, then it would crest up and flow over the private driveway (that acts like a dam). But, since the water downstream is held back in the ditch by the configuration of the downstream cross culvert, the cross culvert takes over the control of the lake during extremely high flow conditions.

This means that the size and elevation of the private driveway culvert is less of an influence during high flow conditions.
