**TOWNSHIP OF SOUTH FRONTENAC
COMMITTEE OF THE WHOLE MEETING
AGENDA**

TIME: 7:00 PM,
DATE: Tuesday, March 24, 2015
PLACE: Council Chambers.

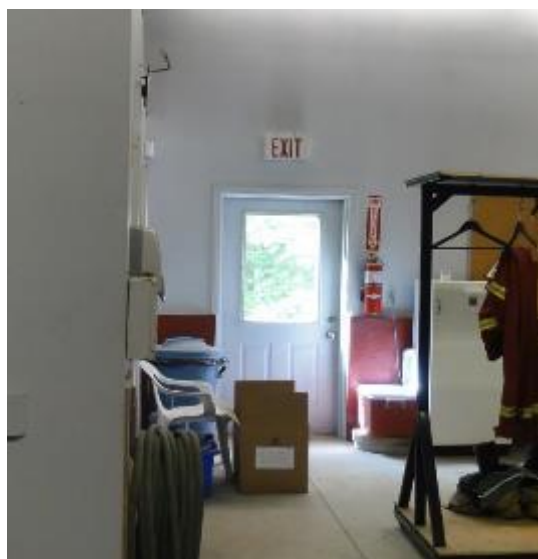
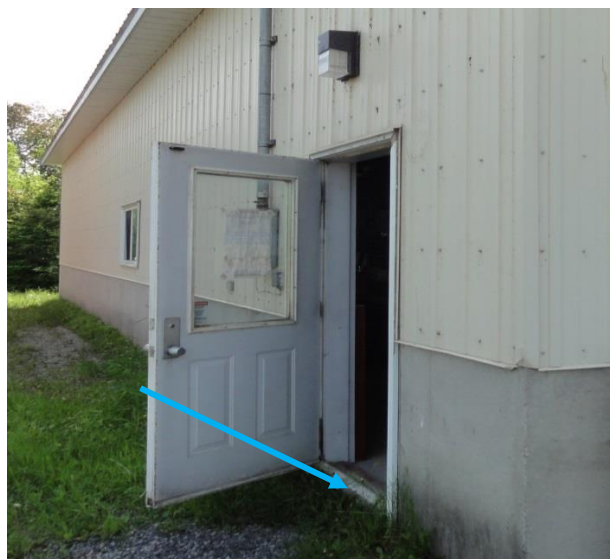
Additional item of concern at station 1

The exit noted in these two pictures has a fall hazard as it opens out into a bush area and the step down is approximately 8 – 10 inches. Consideration should be given to incorporating a more gradual step down where possible.

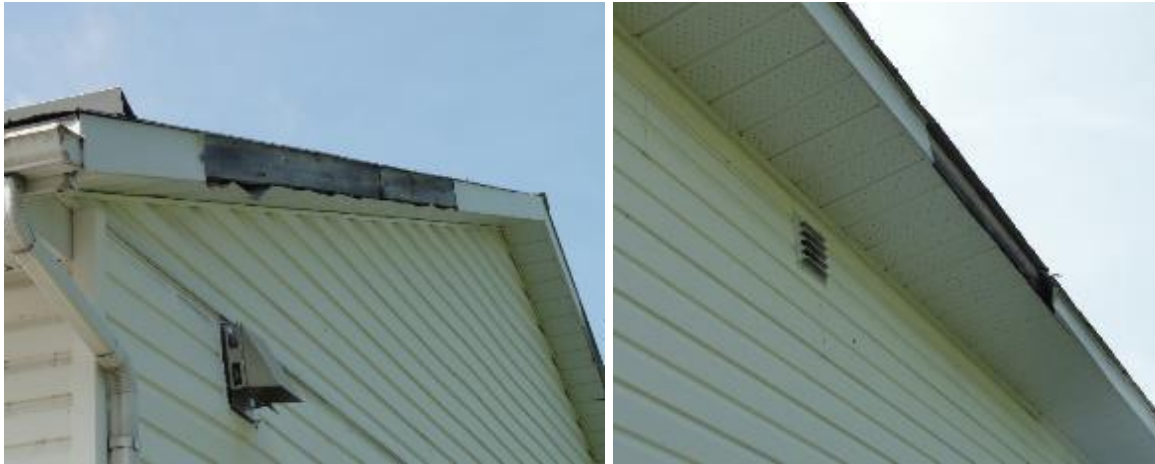
Pictures noting some of the items for station 2 requiring repairs

Wind damage to the siding needs to be repaired

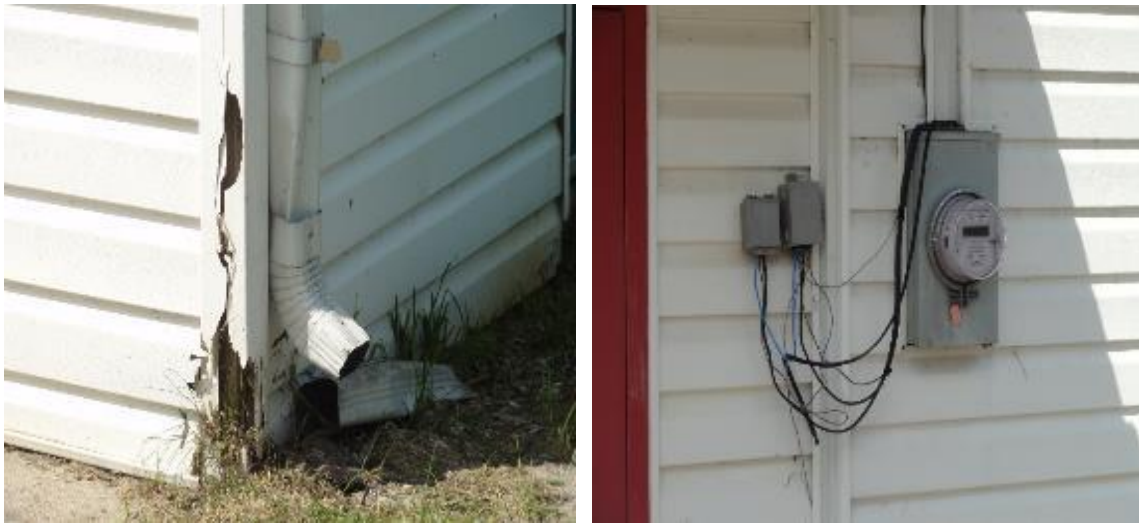
Electrical issues as noted in the picture were observed and should be addressed.

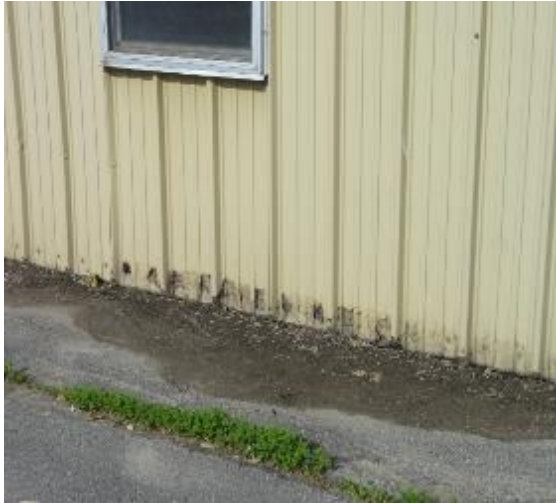
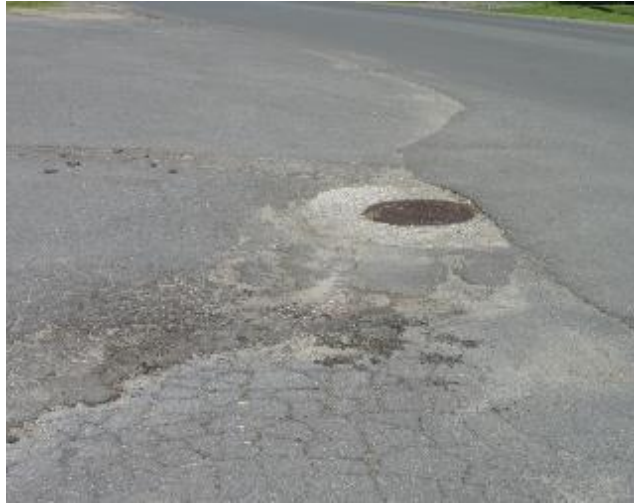
Pictures noting some siding damage due to water/grading issues along with some front driveway paving repairs required for station 4

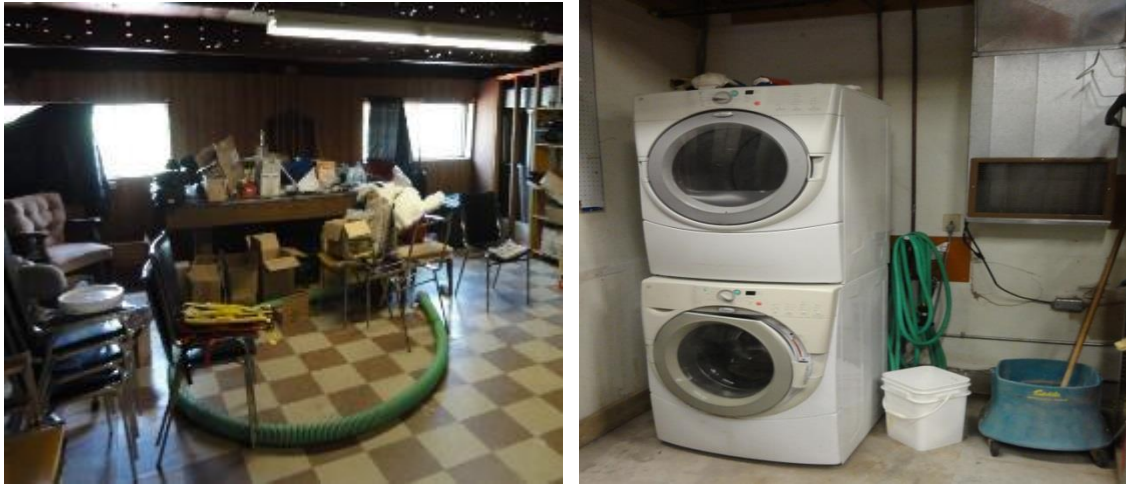
Pictures of some items noted in station 5 relating to storage and washing of gear

Storage issues were noted throughout the building but were most prevalent in the upper floor area of the station.

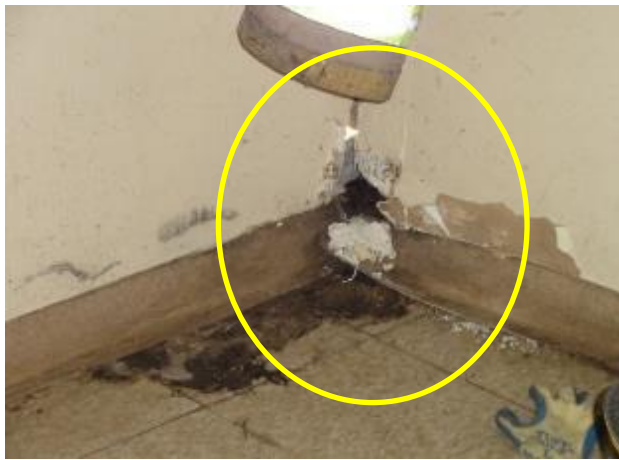
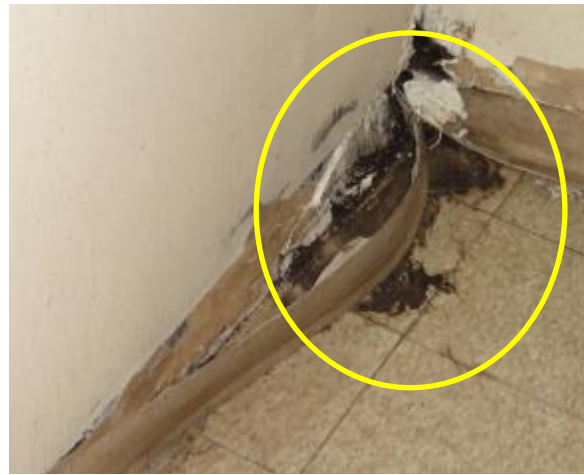
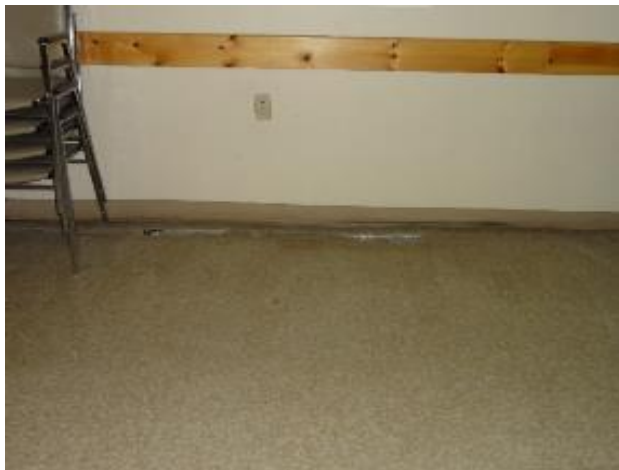
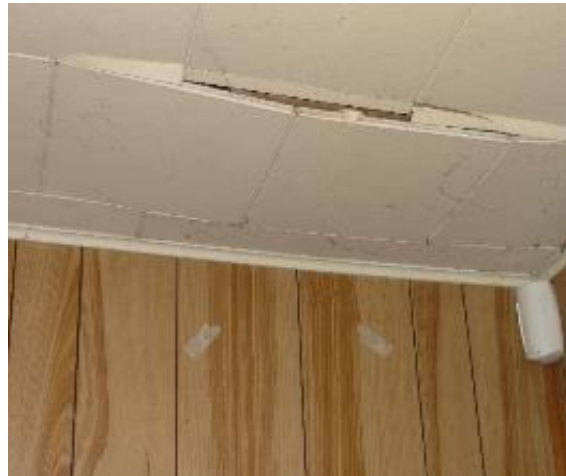
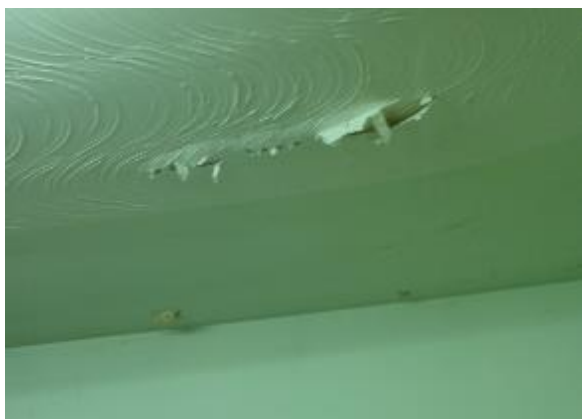
Pictures associated with mold and water damage issues at station 6

Some major mold and water damage issues were noted during the inspection of this station. A full mold remediation program needs to be implemented with this station.

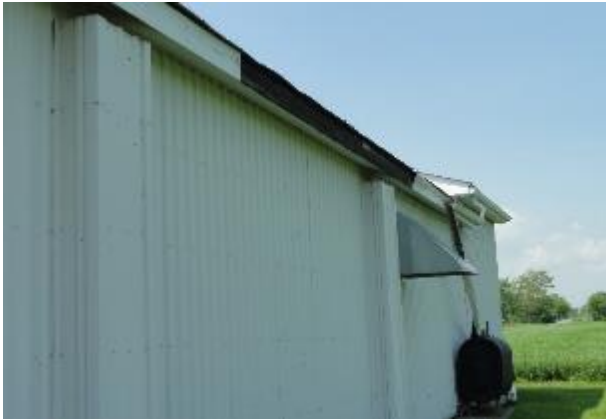
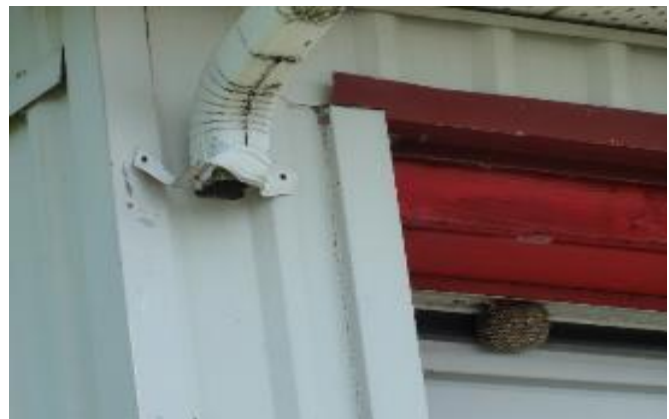
Pictures of some items of concern at station 7

Wind damage to the siding and downspouts were noted.

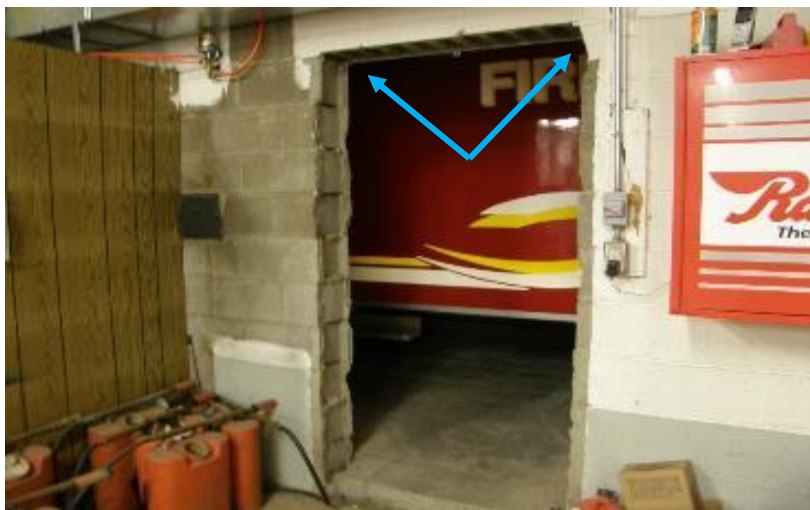
The picture below identifies an area that was cut out in a block wall that requires some structural reinforcement with angle iron.

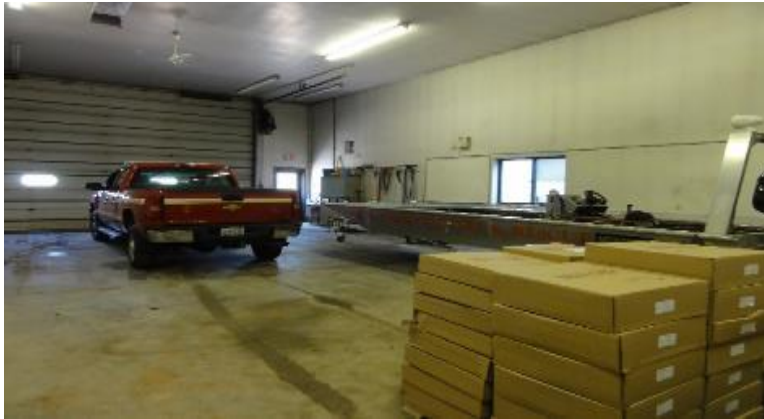
Picture of additional item of concern for station 8

There were no other unique issues noted with this station other than what is identified in the building inspector's report. However, it was noted that during the winter months (November to March) the fire department is required to vacate this vehicle storage space to allow for snow plows to be parked.

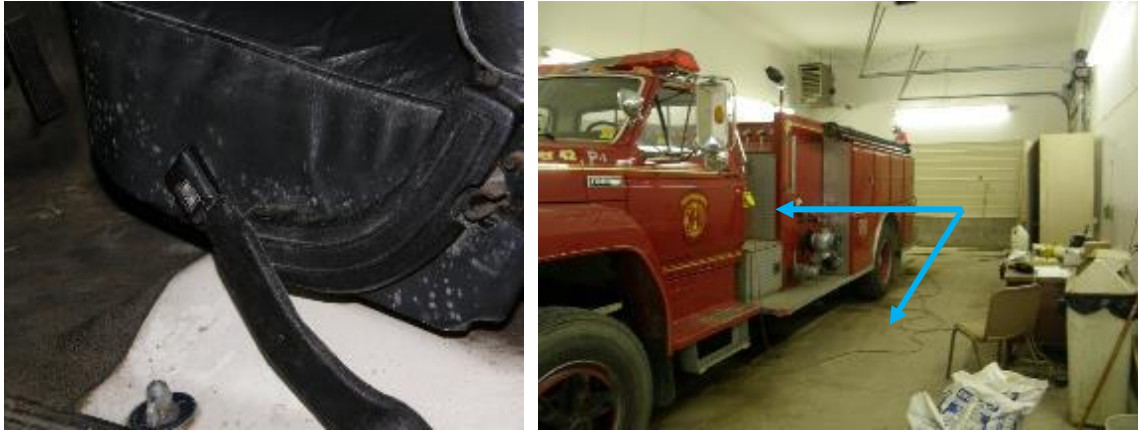
Additional pictures relating to concerns with station 9

During the review of station 9, electrical cords for the fire vehicle were found to be laid across the floor. There were also signs of mold found in the passenger cab of the vehicle.

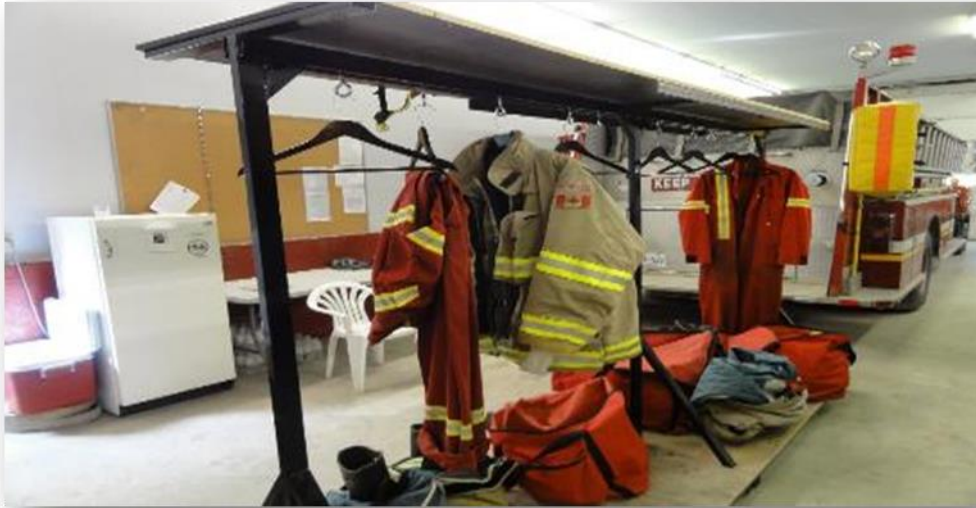
- 1) All of the fire stations lack suitable safe storage of the firefighter's personal gear. With all of the gear left out in the open, it is susceptible to contamination by the exhaust fumes from the vehicles. This contamination from the vehicle exhaust fumes is a concern as it can degrade the efficiency of the gear and also create an inhalation hazard to the wearer.

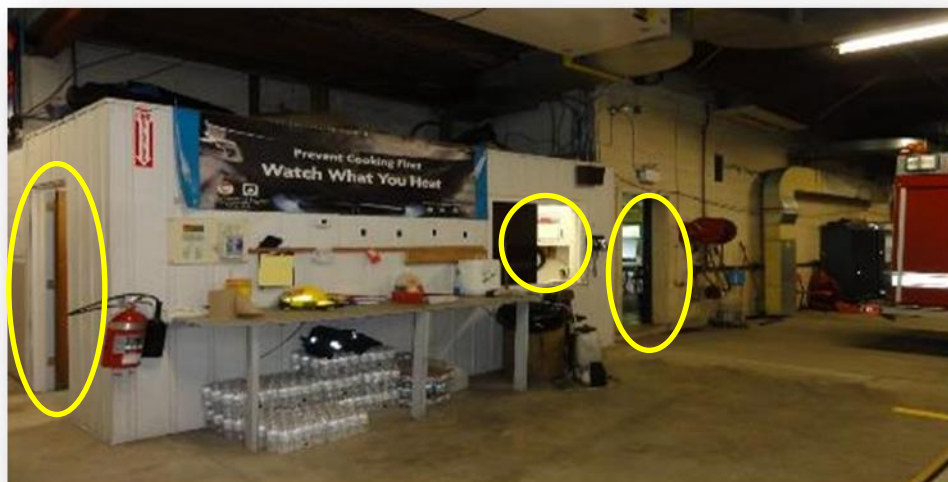
- 2) There is a lack of “self-closing” doors leading from the apparatus floor to the working, training and eating areas of the fire stations. To reduce exposure to the exhaust gases from the vehicles, all of these areas should have self-closing doors and/or proper separations.

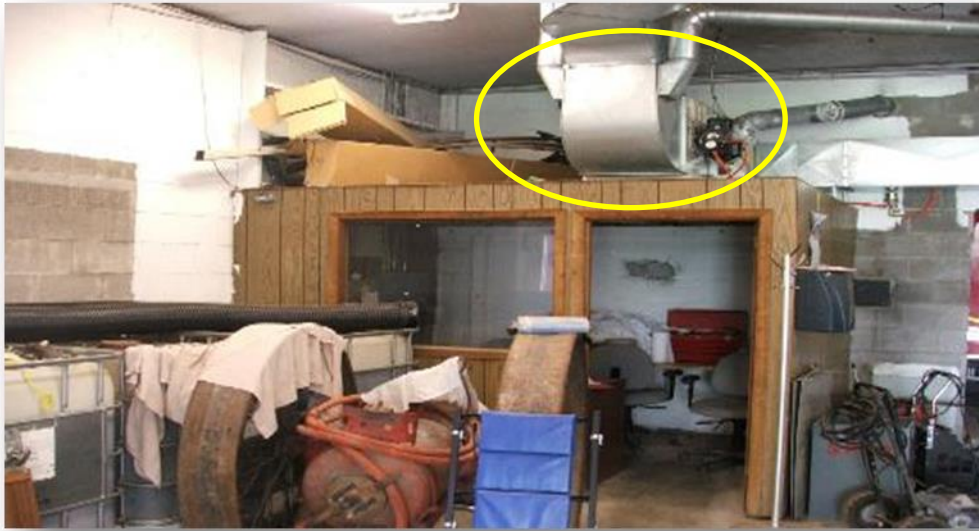
- 3) There was also a notable lack of proper storage areas/facilities for the equipment. This in

itself creates a tripping/safety hazard to the staff. Some of the product is also stored around the furnace system which is a hazard in itself.

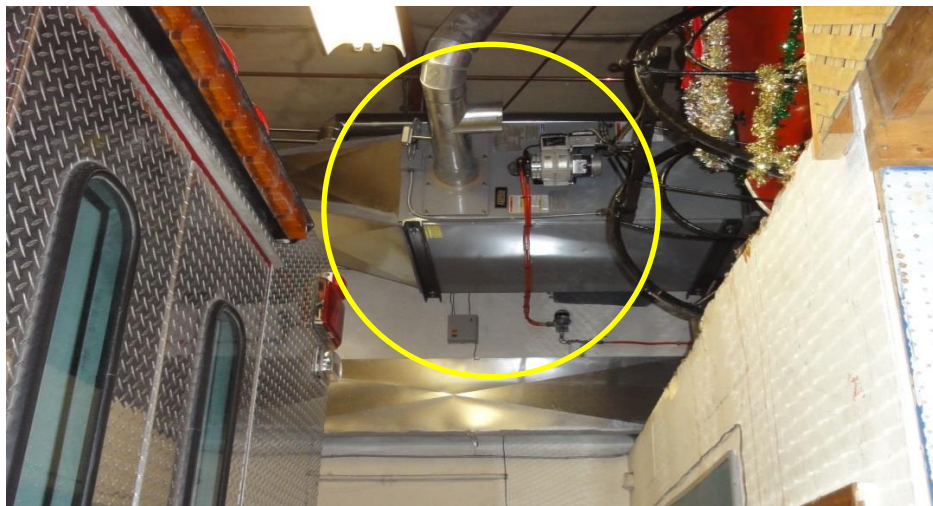
- 4) The furnace systems for all of the fire stations are located on the apparatus (vehicle) bays. This means that exhaust fumes are being taken into the furnace systems and spread throughout the fire station. An assessment should be conducted to see what effect this has on the air quality of each station's office/training areas.

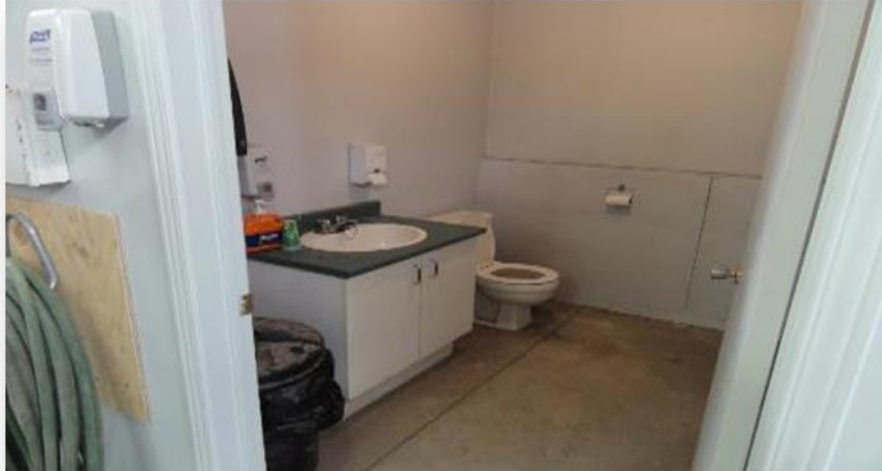
- 5) Washroom facilities for both male and female firefighters were also an issue and should be addressed. However the main concern is the lack of shower/wash up facilities in all but one station – station 2.

Example of general washroom facilities found at most stations.

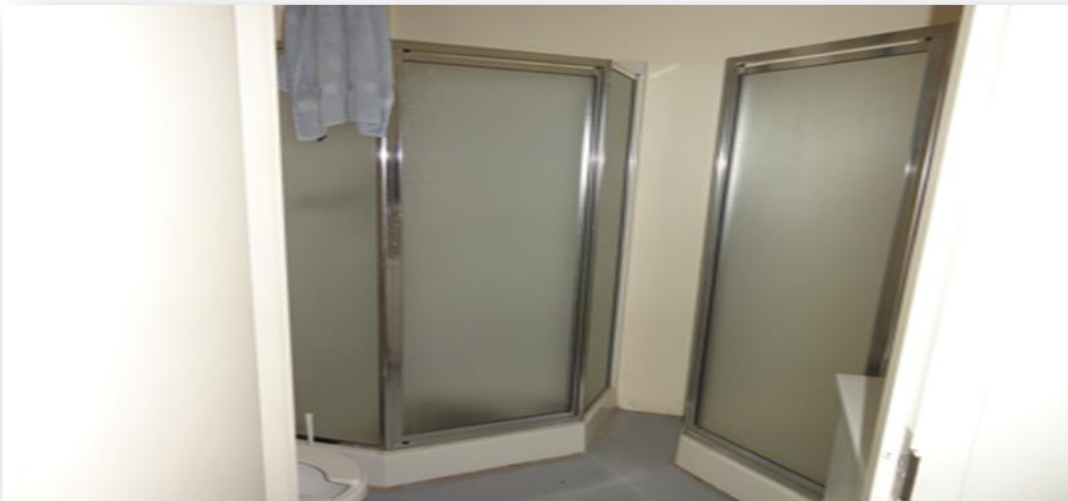
Example of shower facility found in station 2. At the very least a single shower facility should eventually be installed in ALL fire stations. A transitional period which offers “every other station” as a shower/wash up facility would still prove more effective than what is presently available.

Firefighters who have become contaminated with such things as bodily fluids or products of combustion should not be expected to drive home in their personal vehicles and risk the chance of spreading these contaminants.

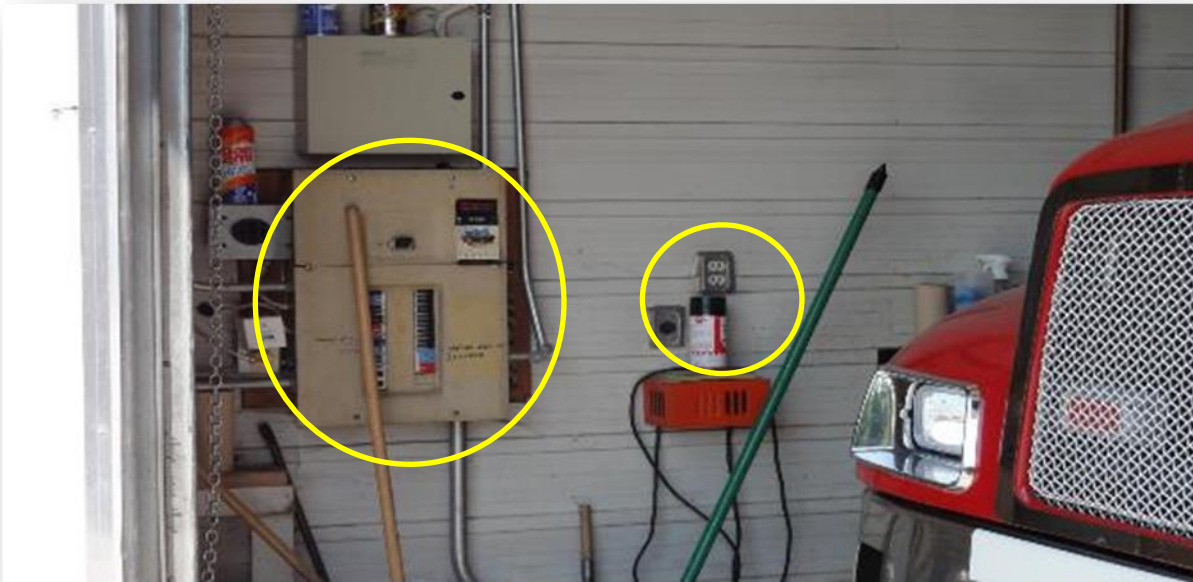
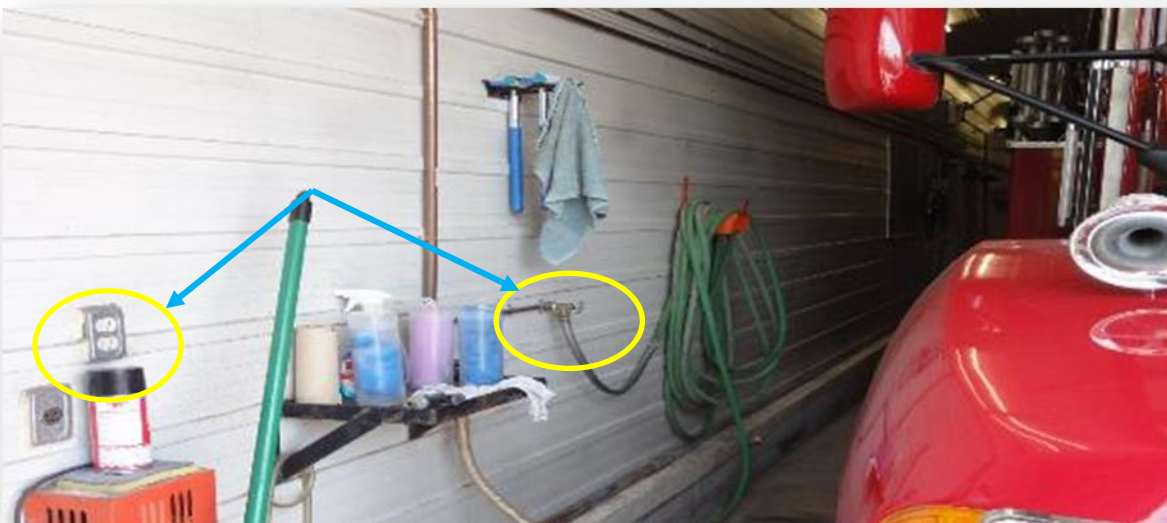
- 7) Receptacle's that are on the apparatus floor that are susceptible to water contamination should be outfitted with GFI's.
- 8) Electrical panels should be properly covered and protected from any physical damage or contamination from water.

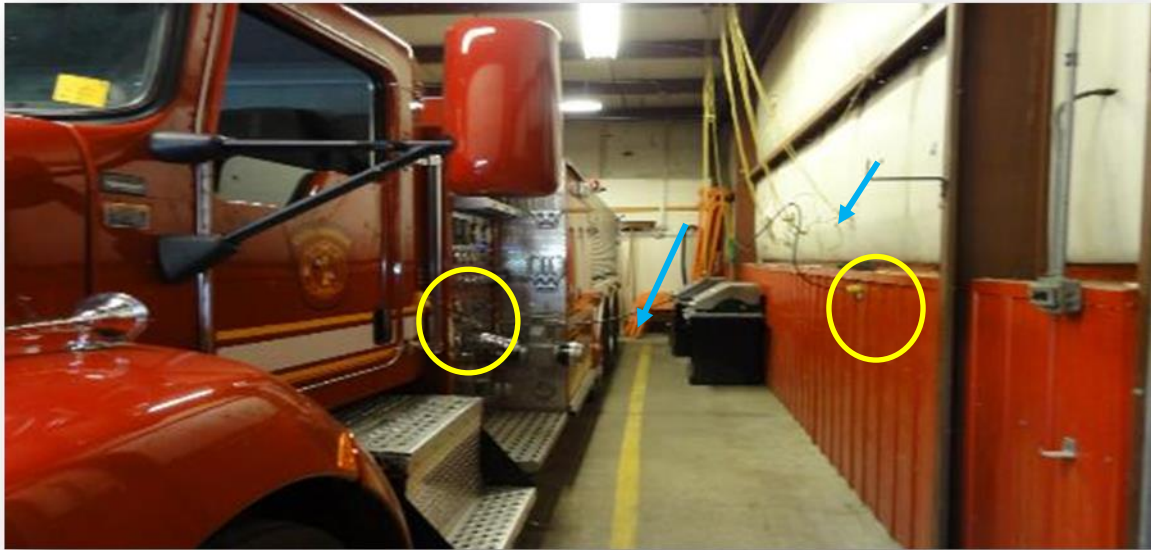
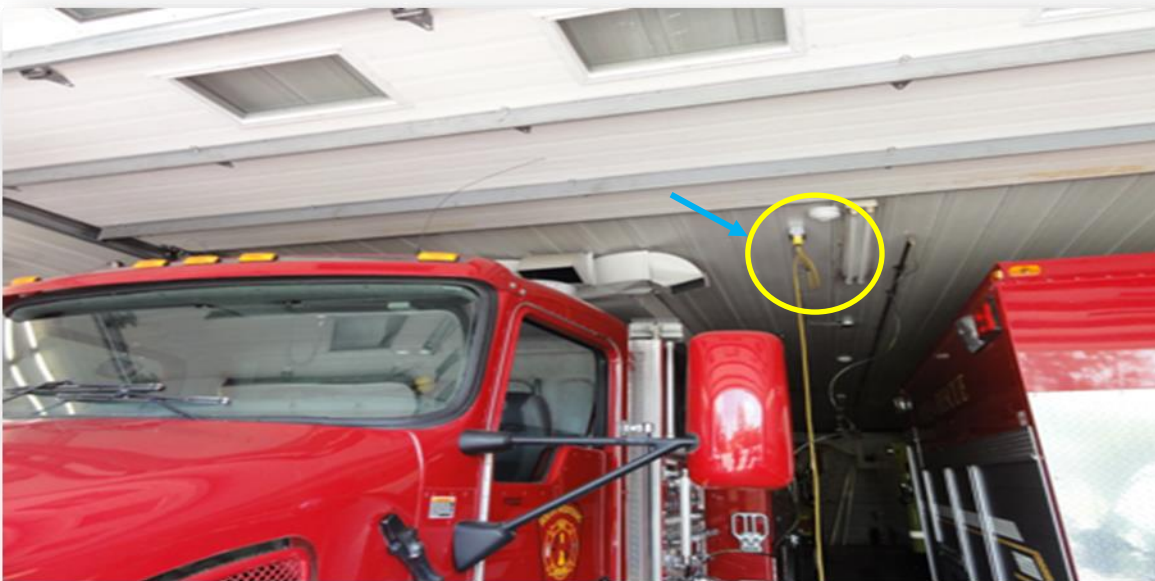
- 9) Electrical plug ins for the vehicles should have the cords properly secured and suspended so

as not to create a safety hazard

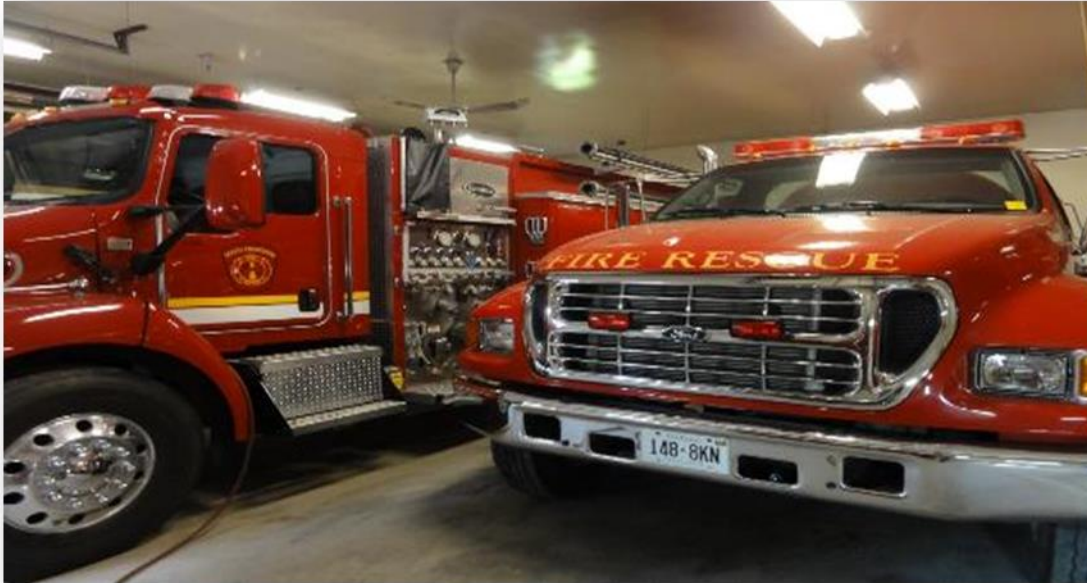
- 10) Space between vehicles must allow for safe and easy access between vehicles to as to reduce the possibility of persons becoming trapped between vehicles as they are being driven in and

out of the fire station.
