Committee of the Whole – Regular Meeting
March 5, 2014 – 9:00 a.m.
The Frontenac Room, 2069 Battersea Road, Glenburnie, ON

Report 2014-029

**Re: Corporate Services – Performance Concepts Consulting Inc. –
County of Frontenac Strategic Plan Draft Report**

Joint Project for Frontenac Townships

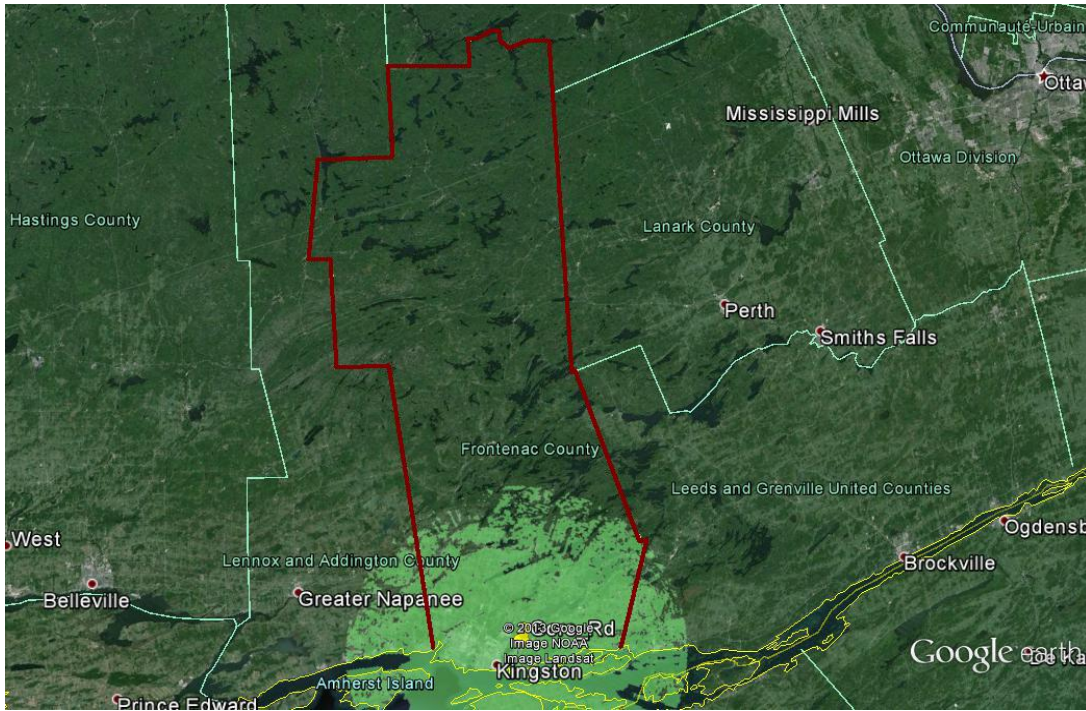
Combined Sites 95/95 Serviceability Area

This combined plot shows the estimated 95/95 serviceability for the Frontenac region when combining all of the results from the 5 sites. Dead spots are apparent in large sections of Central and North Frontenac and some sections in South Frontenac. The conclusion from this analysis would indicate that current RF Coverage is not adequate to provide reliable Radio Communications across the entire Frontenac region.

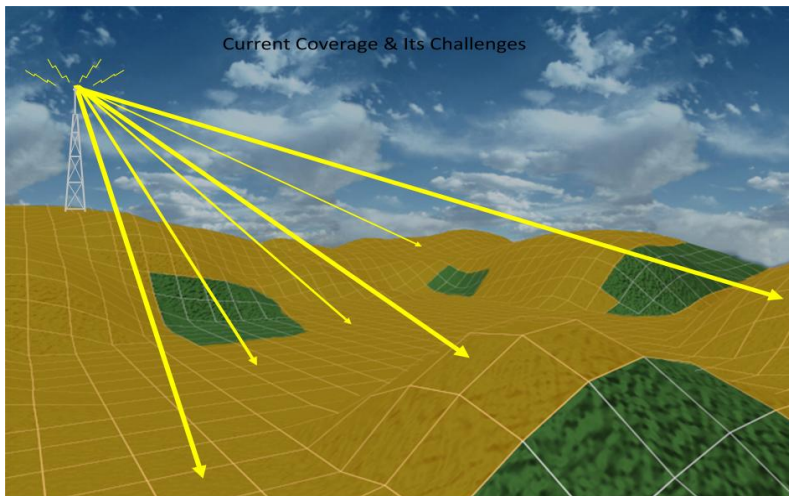
A Multicast System is defined as a radio system where different radio frequencies are used at each Repeater site within the radio system. Each site is assigned a unique frequency or set of frequencies for service within the coverage area provided by the specific repeater(s) located at that site. This means that for each repeater, separate frequencies are assigned. No coverage overlap is possible, nor can Users "roam" between sites without changing frequencies. Communications across the County or even across multiple Townships is not supported. This results in a very restrictive communications environment, inefficient Spectrum utilization and a lack of interoperability across the regions. Also, within a specific coverage region, there are "dead spots" due to local terrain, since only one transmitter site is servicing the users in the designated areas. As depicted below, the yellow regions are supported, but due to terrain shadowing, the areas in green have poor or non-existent coverage. As a result, the current infrastructure has not been optimized to meet Public Safety coverage standards (i.e. 95% coverage ,95% of the time)

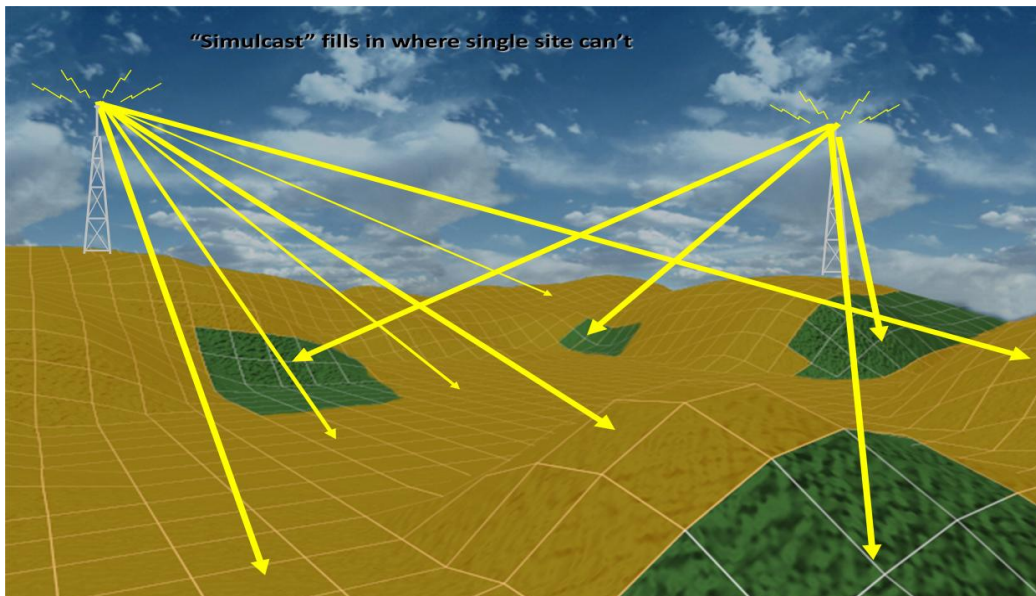
As illustrated in the diagram below, utilizing a Simulcast system, with multiple transmitter sites on the same frequency, will eliminate dead zones, ensuring improved communications coverage.

From evaluating Frontenac's requirements, it is recommended that a Simulcast Transmission System be implemented as part of a Network refresh. A Simulcast System is defined as a radio system where the same radio frequencies are simultaneously broadcast from all tower sites within the Network. This allows same radio frequencies to be used throughout the entire coverage area and supports seamless communications throughout the radio system's coverage area. Not only will this optimize radio frequency utilization but it will also significantly improve coverage in areas with difficult terrain, like in Frontenac County. A Simulcast system will also improve in-building coverage since signals from multiple sites on the same frequency overlap to provide additive signal strengths.
