**TOWNSHIP OF SOUTH FRONTENAC
COMMITTEE OF THE WHOLE MEETING
AGENDA**

TIME: 7:00 PM,
DATE: Tuesday, March 24, 2015
PLACE: Council Chambers.

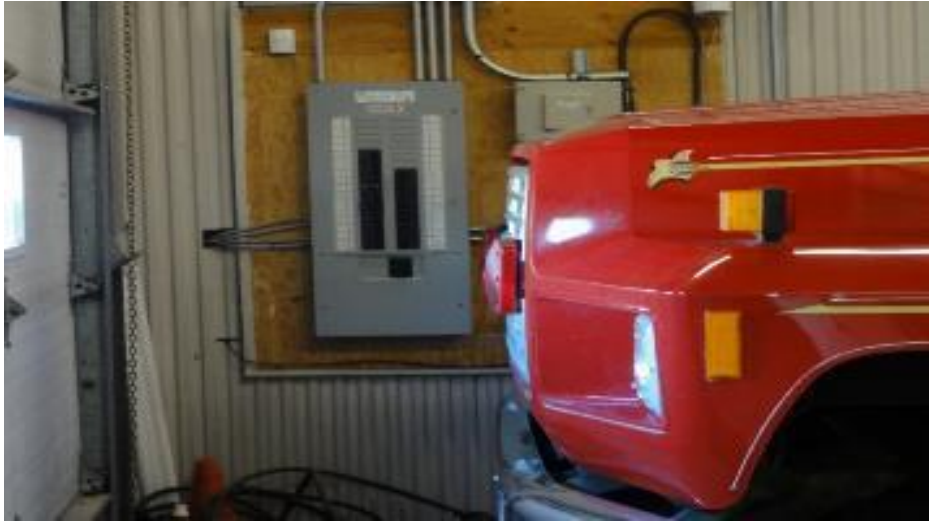
Picture noting the electrical panel that needs to be protected from water contamination at station 3
